Second Report of the Vishwamitri Committee

(Constituted by the Hon'ble Gujarat State Human Rights Commission)

HRC/2024/PRESS/205/Vadodara City/legal-1

20 July 2025

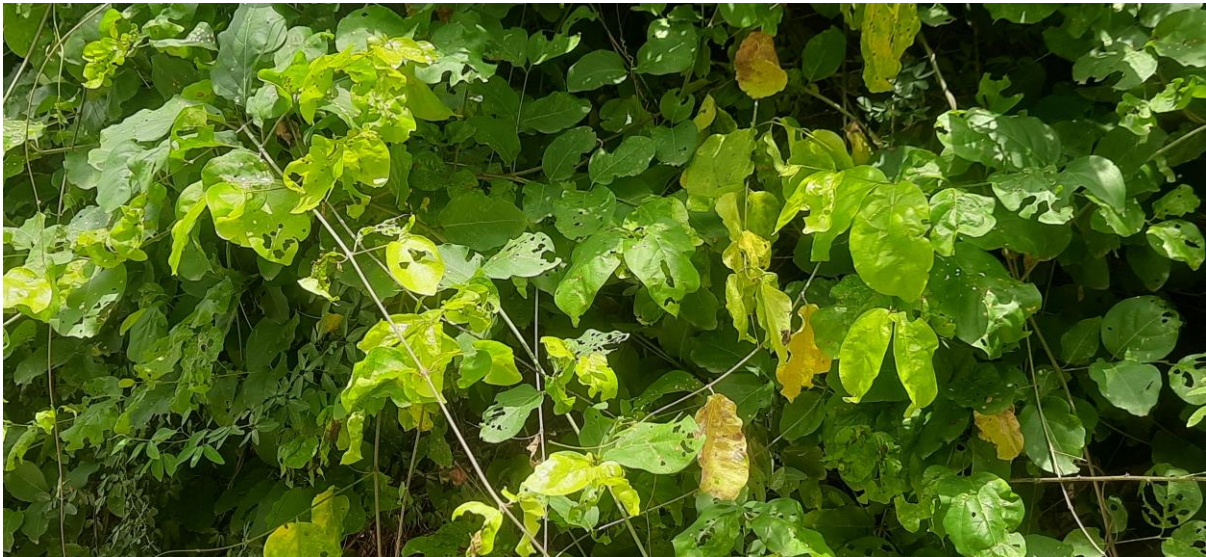
Combratum ovalifolium (brighter bigger leaves in opposite pairs) *Passiflora foetida* (angular broad, alternate leaves) both are extensive climbers on shrubs, barrier to rain splash, also provide shady habitat to small birds and other animals.

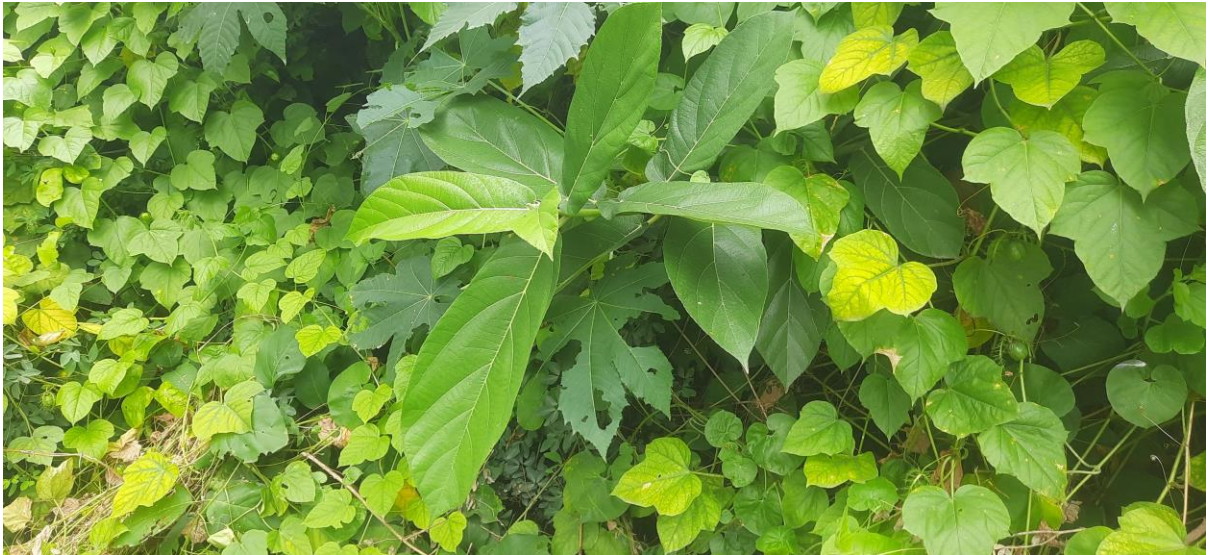
Passiflora foetida (leaves with three tips) is a climber that has covered *Ficus hispida* (big leaves)

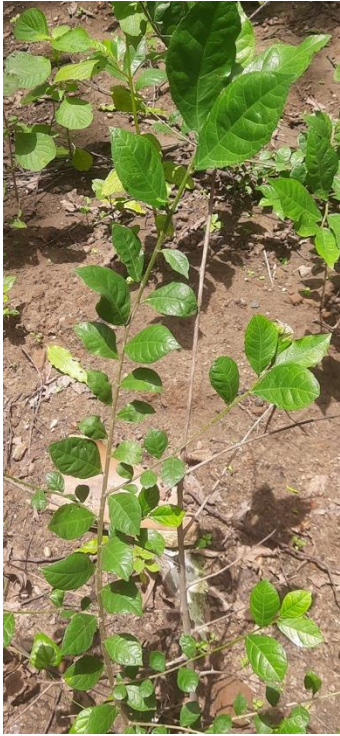
Sapling of *Streblus asper* (sand paper tree) is native species in central India, including Gujarat. It forms thick evergreen canopy of dark green leaves that provide shelter to small birds. Fruits are relished by bulbul, koel and mynah.

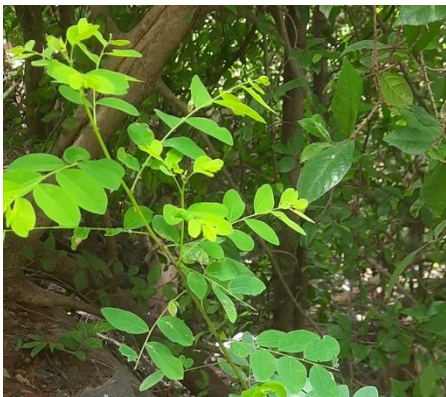
Kirganelia reticulata (Kamboi, Shivi) plant grows on bank slopes along with *Streblus asper* (Haredo, sand paper tree) and *Ficus* species as seen here *Ficus religiosa* (Piplo) in the background. All these native plants provide resilient ecosystem supportive of native fauna.

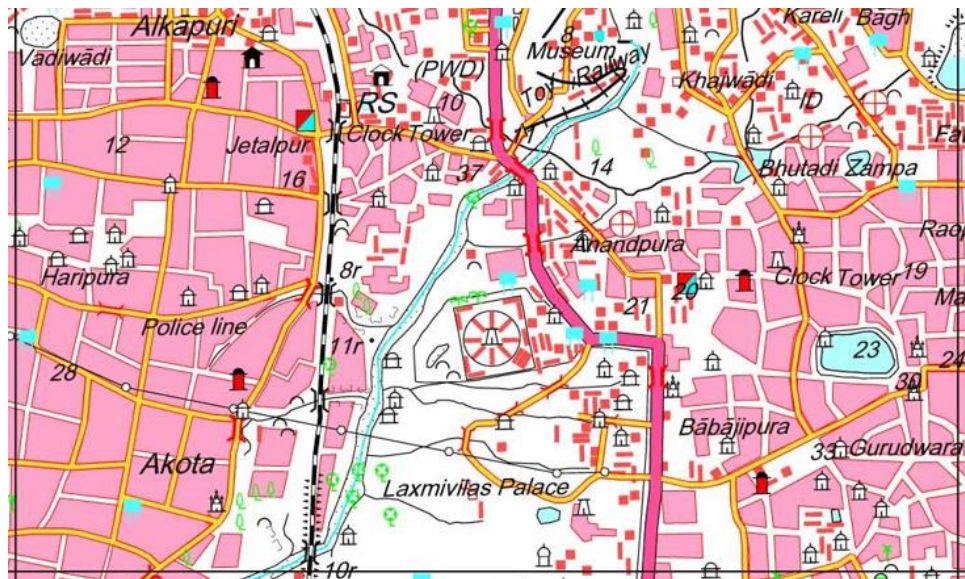
1969-70 Map Updated 1998-99

The referred land is an important ravine that has a natural storm water way passing through it. This waterway / 'kaans' drains waters from the SSG hospital area and Jail Road. Any form of blocking either through filling or physical barrier will lead to increased waterlogging in the above mentioned areas.

Also, it is important to note that such obstructions to natural flows of surface and subsurface waters may lead to sinkhole formations similar to Akota area of the city as explained in Annexure XIII.

Therefore, it is pertinent that the properties in the floodplain areas, and those that harbour tributaries, kaans, and natural water ways, be mapped and subjected to special development regulations through effective planning tools to facilitate the natural flow of water. Hence, future flooding and waterlogging incidents can be prevented.

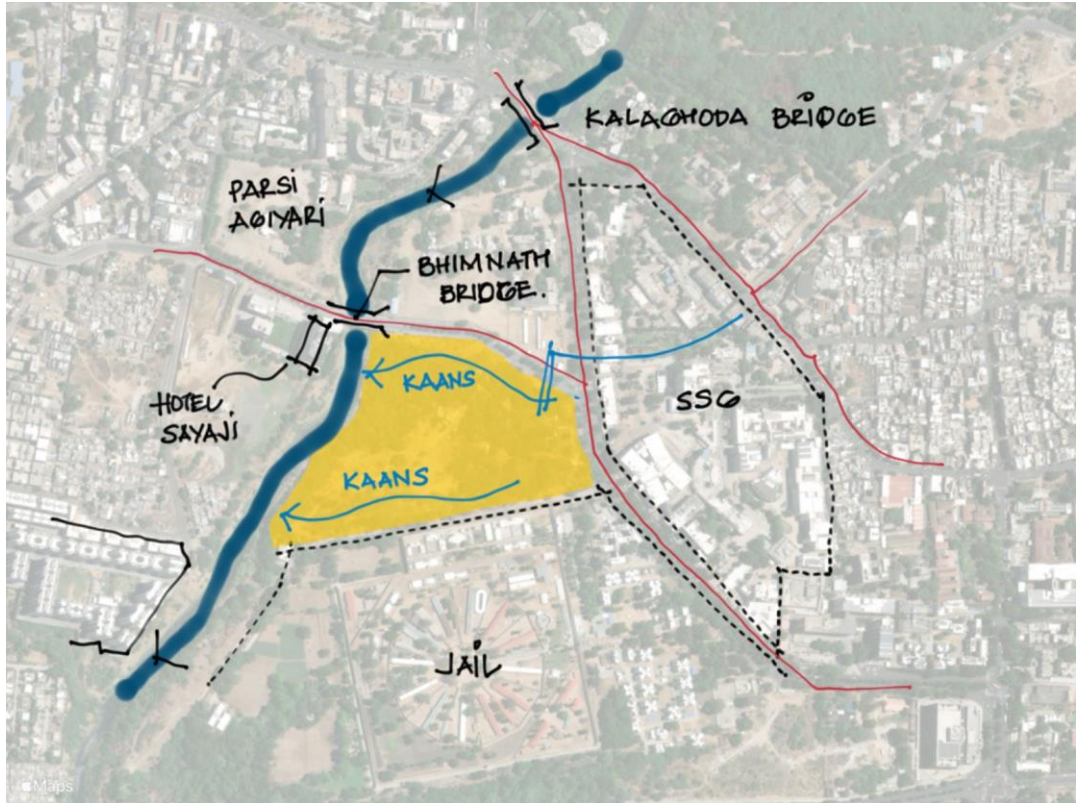
The images shown herein depicts transformation of natural waterways (kaans) stretching between SSG Hospital and Kirti Mandir areas to the Vishwamitri River, which is prominent in the 1896, 1962, and 1972 Survey of India topo sheets. Systematic construction of roads, compound walls and buildings over time have obstructed the flow of storm waters resulting in increasing waterlogging on the Jail Road.

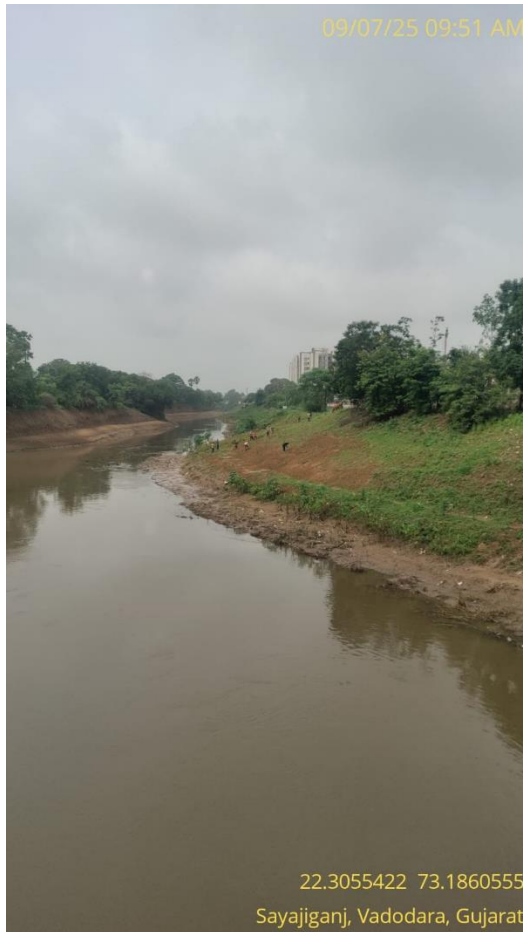
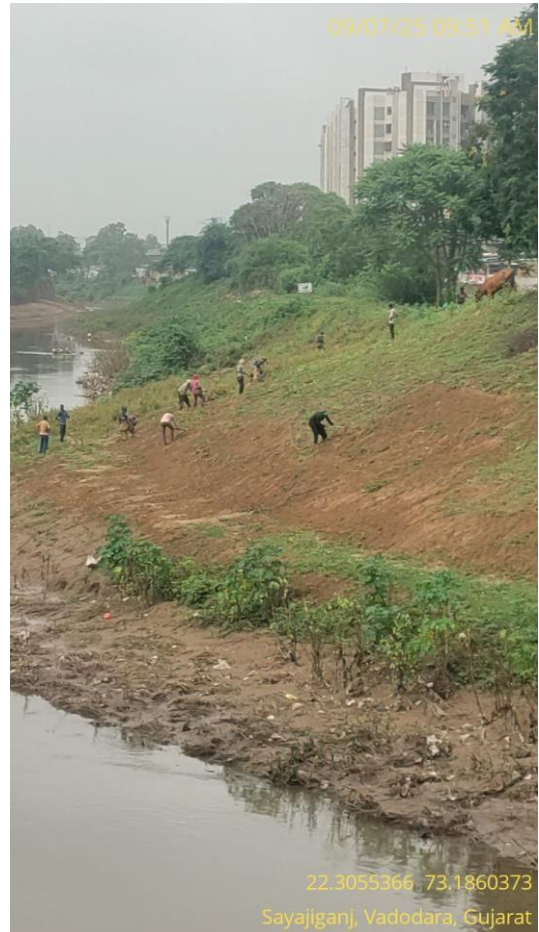
20. At the bank adjoining the new Sayaji Hotel, removal of established vegetation was observed by the committee members on 07.07.2025, for the purpose of installing coir works. The committee suggested that this work be stopped for the following reasons: (a) this bank is not an erosion prone area, there is no plan to further

desilt the areas and the vegetation has already stabilised the bank, and (b) such work when undertaken in mid monsoon season will expose the soil and make it prone to erosion. Action to stop the said work was promptly taken by the VMC.

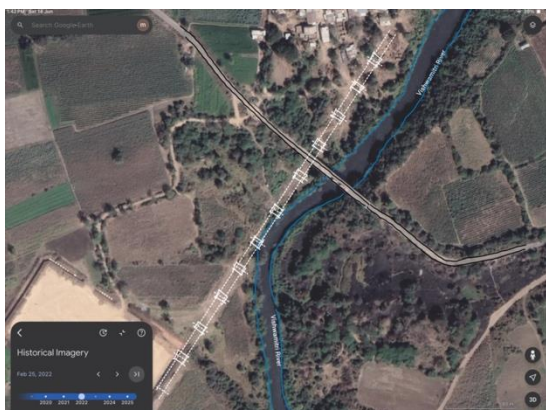
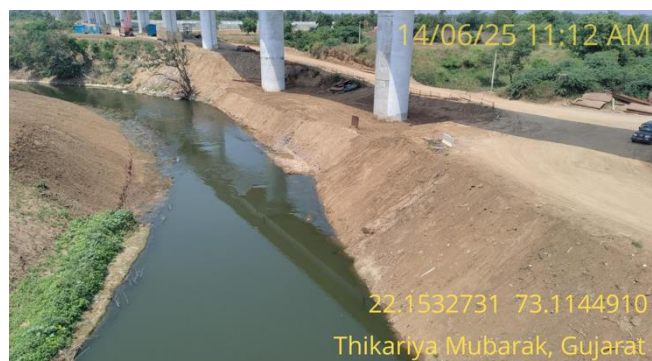
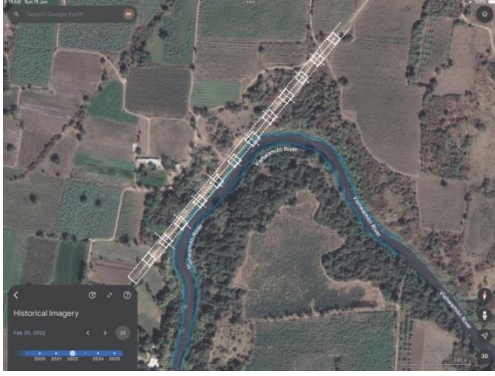
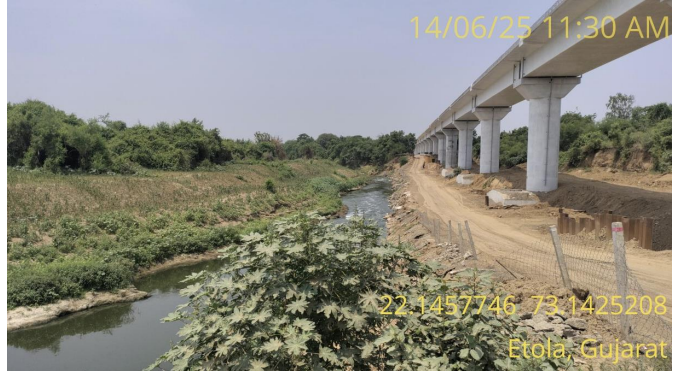
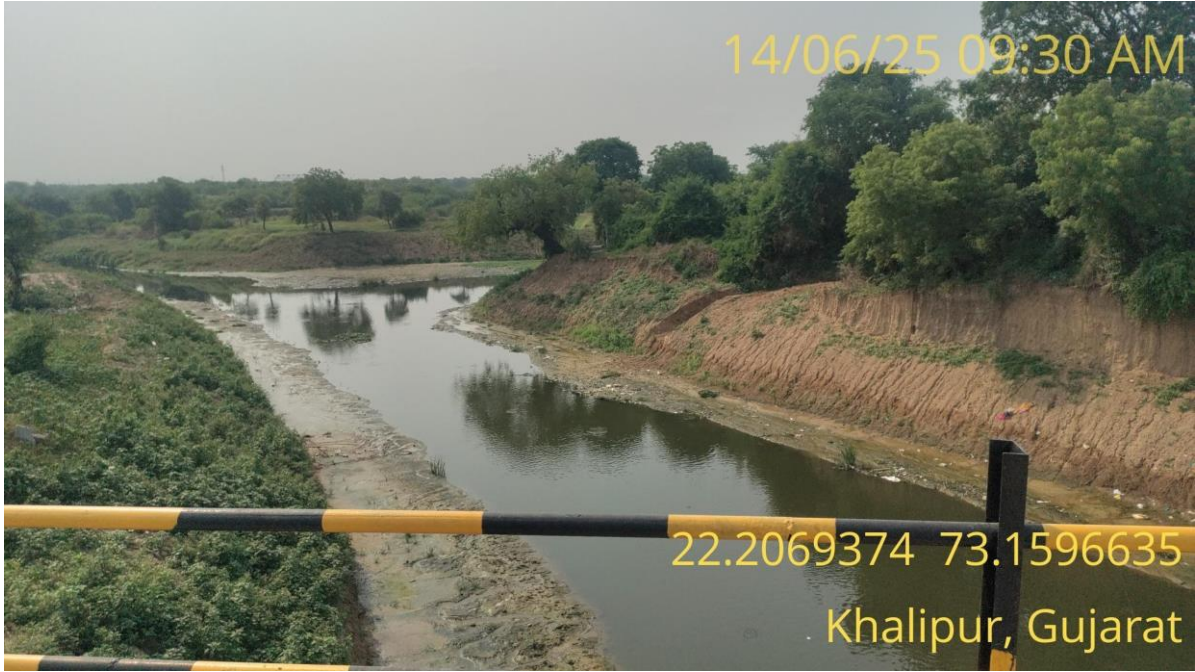
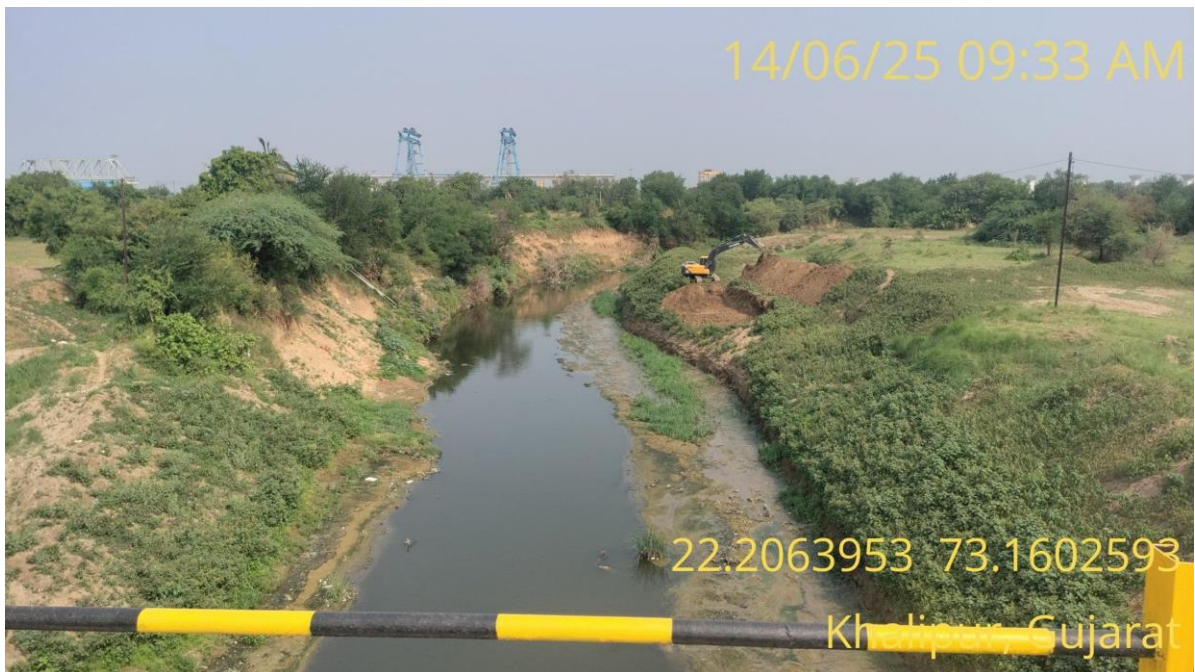
1. Natural vegetation has sprouted at many locations along the river.
2. It was observed that the NHSRCL has not yet completely removed the debris from their work locations as agreed upon in previous meetings.
3. At 2 locations, banks have been stabilised using debris by the NHSRCL.
4. NHSRCL has encroached in the riverbed that has constricted the river at two locations.

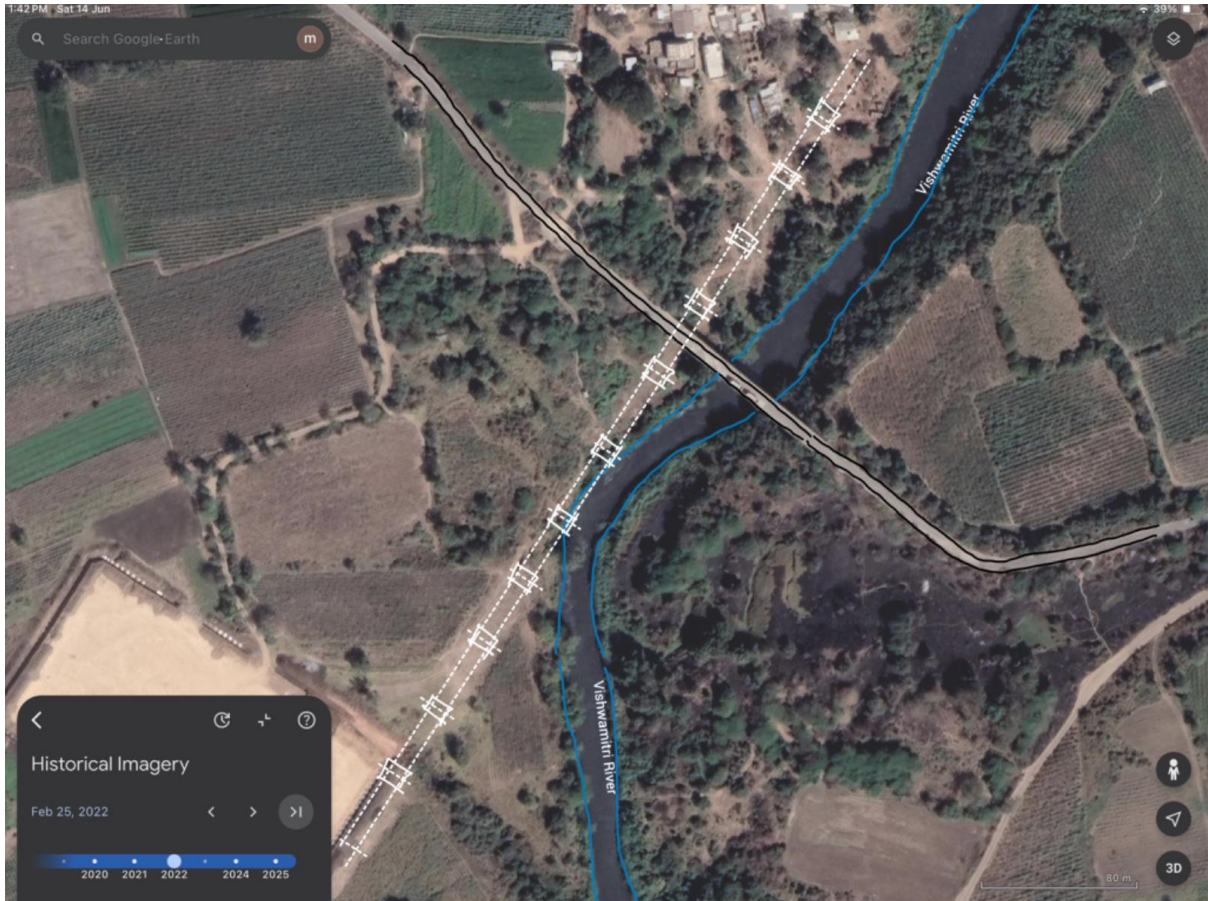
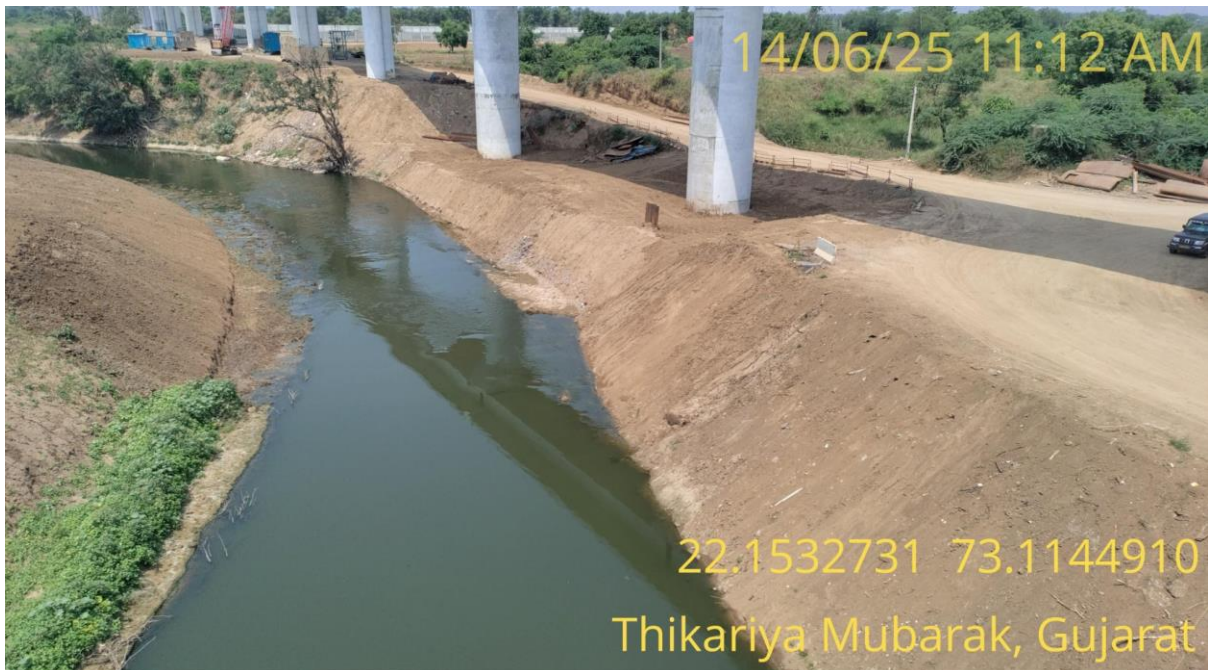
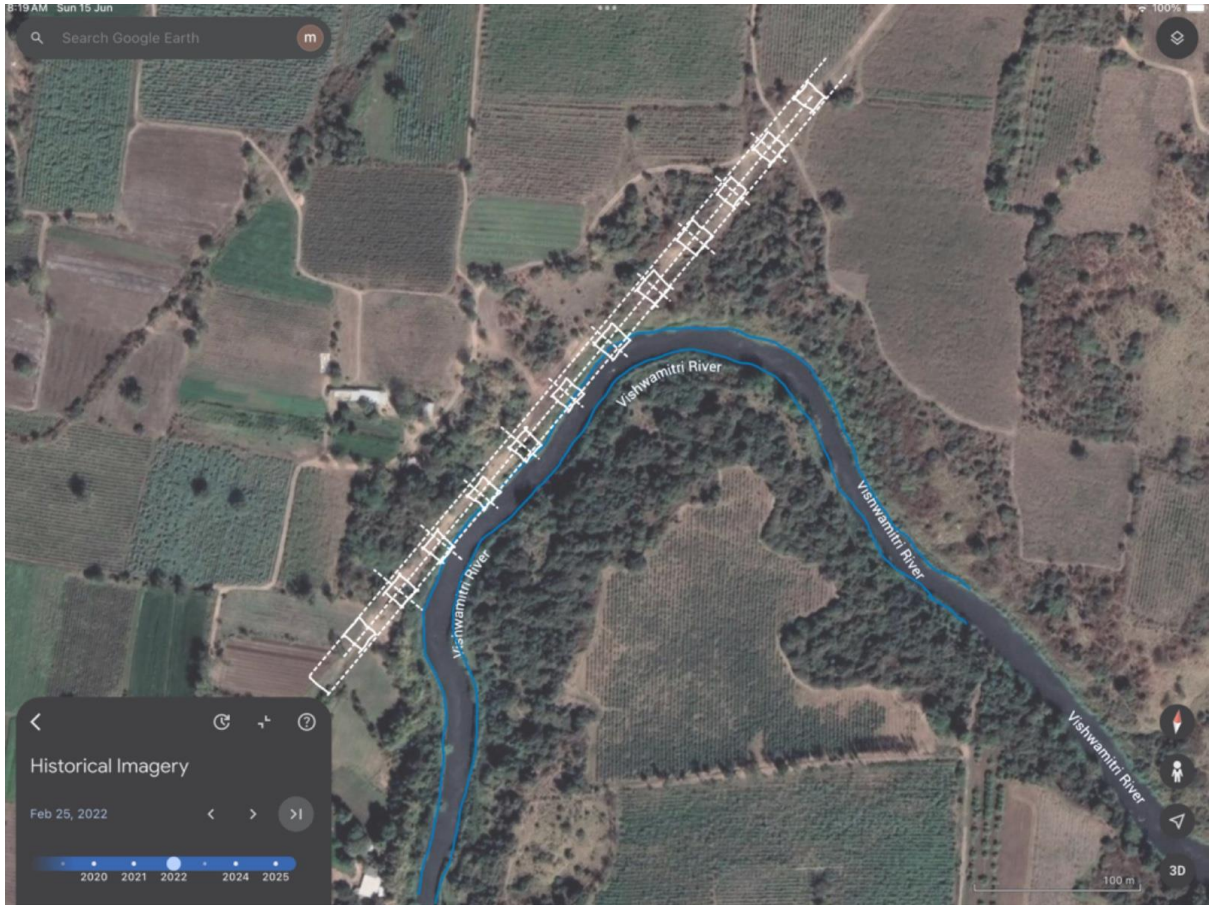
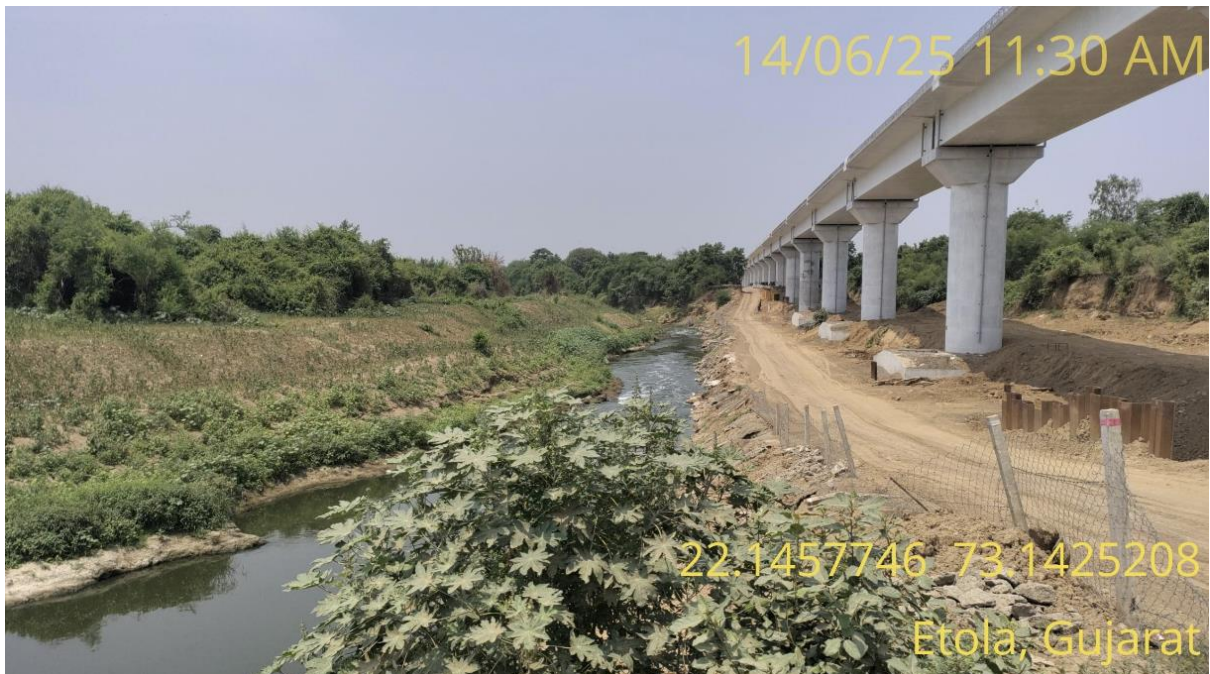
1. The images of the constricted river locations were shared with the NHSRCL officials. They assured appropriate actions before the onset of monsoon and would submit an action taken report.
2. They also agreed to remove debris from the banks and replace it with soil.

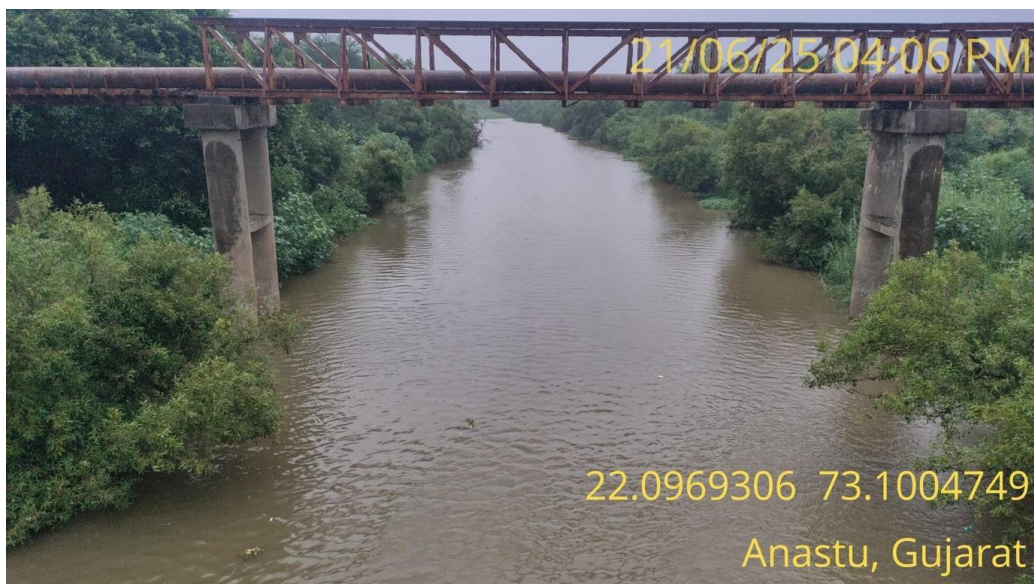
1. At downstream of Delhi-Mumbai Expressway on Vishwamitri-Dhadhar River at Sadad Village, removal of debris is still pending.
2. The issue related to the obstruction of natural flow of water from east to west has still not been addressed by the NHAI. No written submission has been received from concerned authorities.
3. Few villages (Medhad, Husepura) were inaccessible due to rains and photographs of work done were to be shared by the Irrigation Department.

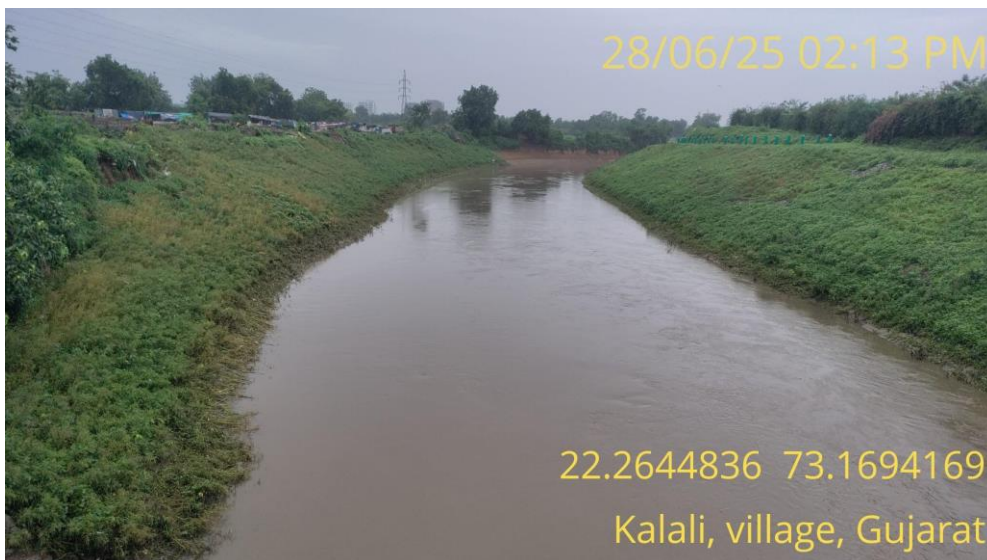
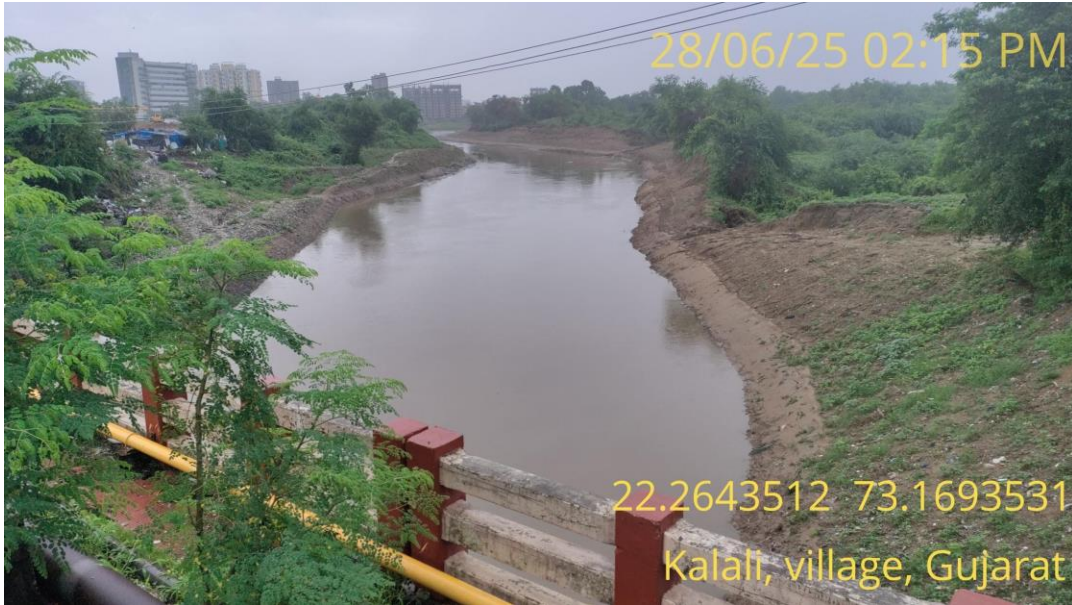
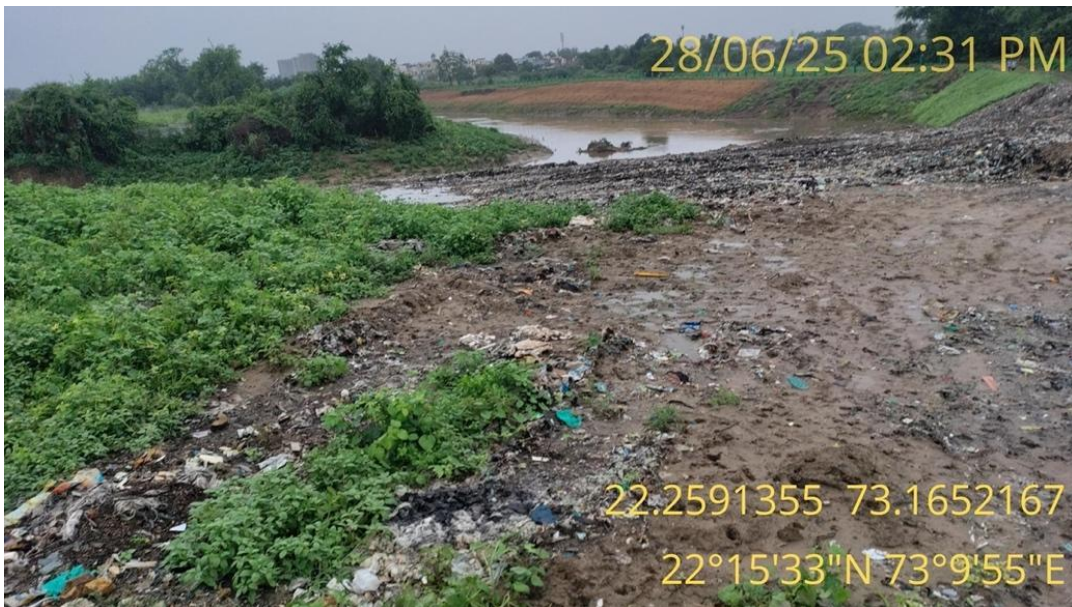
1. MSW has been removed, but there is scope for further removal of waste.
2. Rain spells have led to the emergence of vegetation that would contribute to bank stabilisation.
3. Sewage still continues to flow through storm water drains at some locations.
4. Some ravines are undergoing levelling works that are blocking natural waterways.

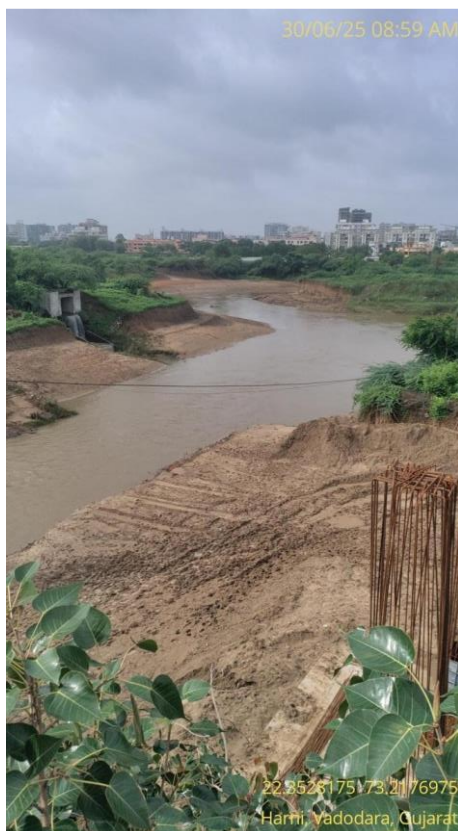
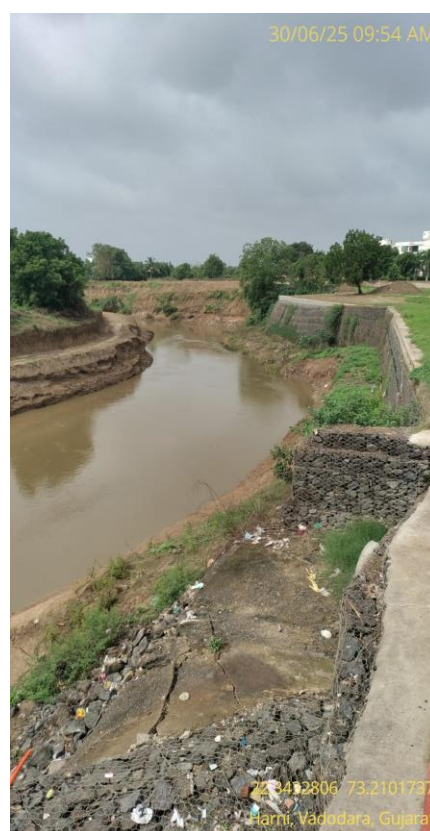
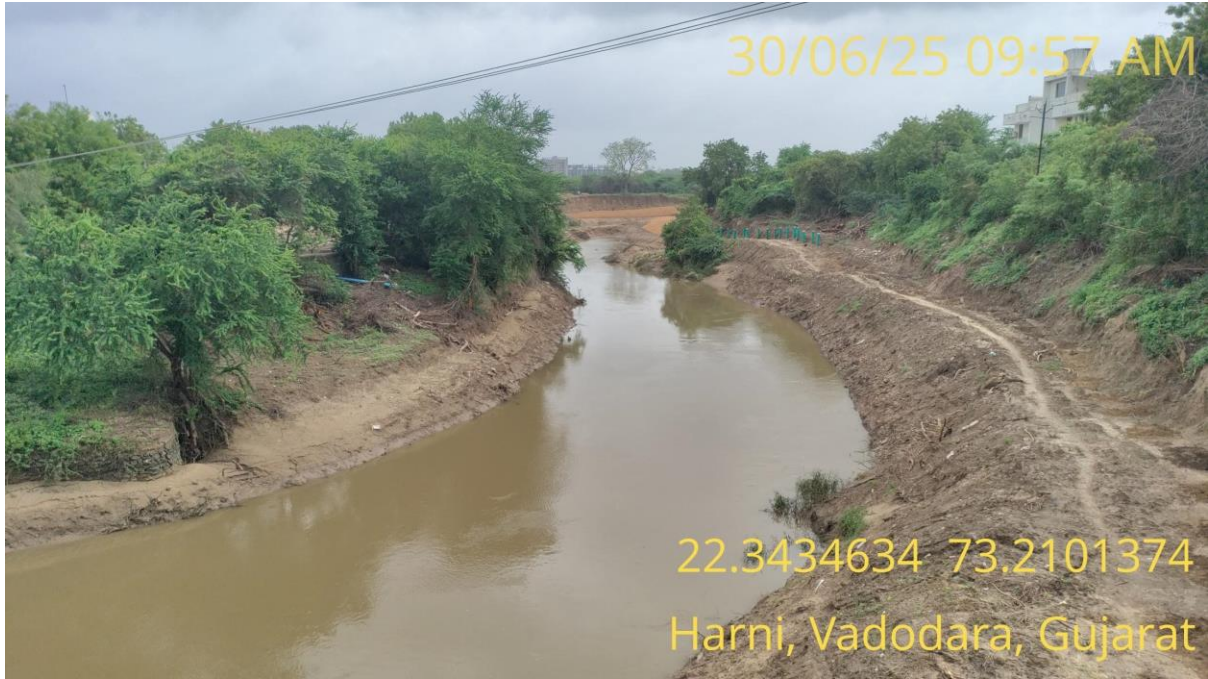
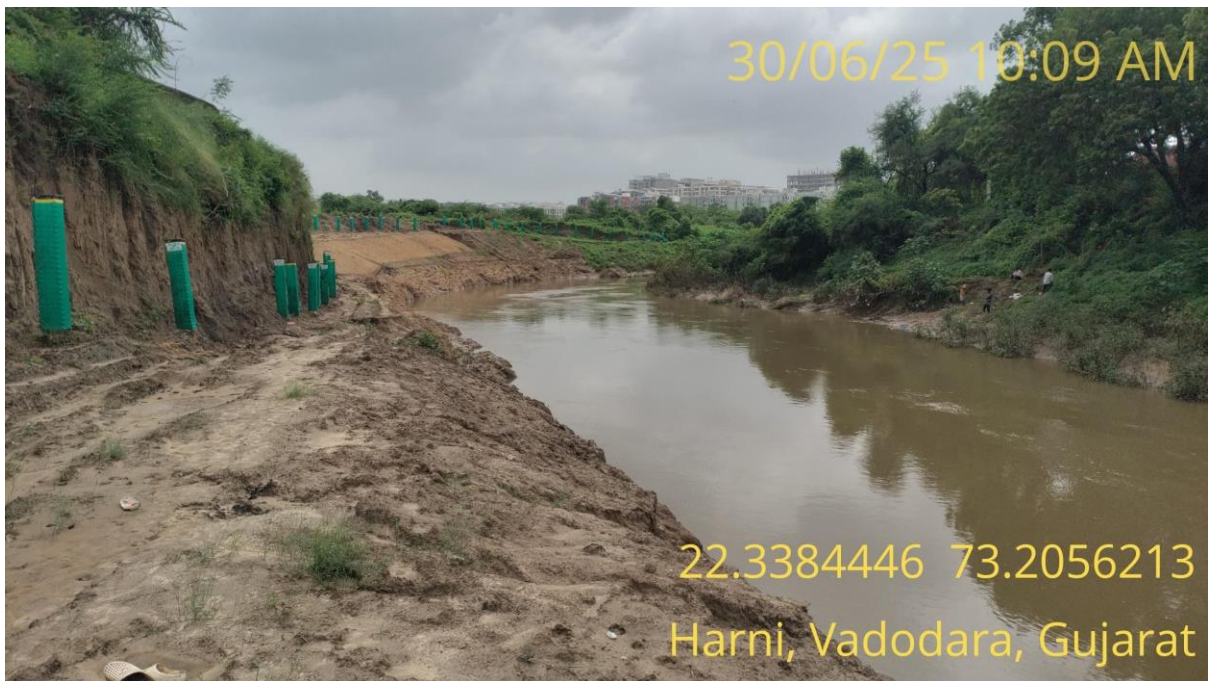
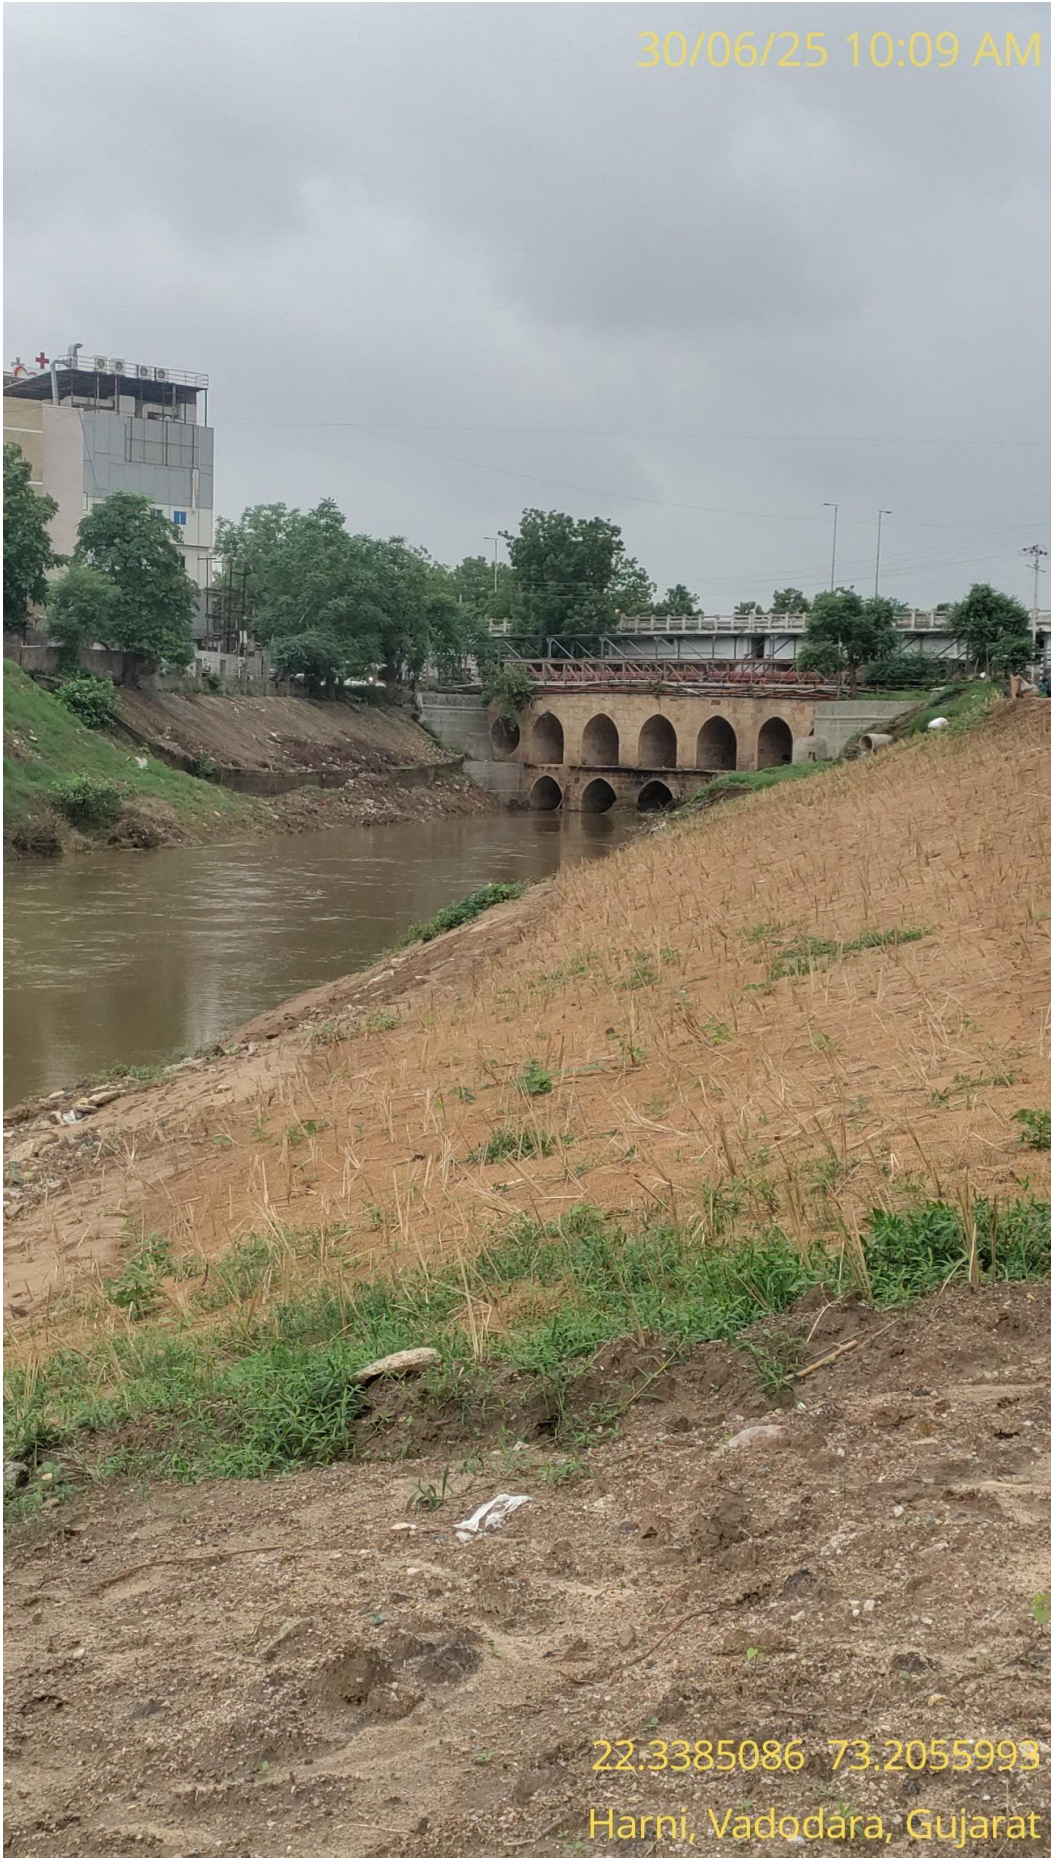
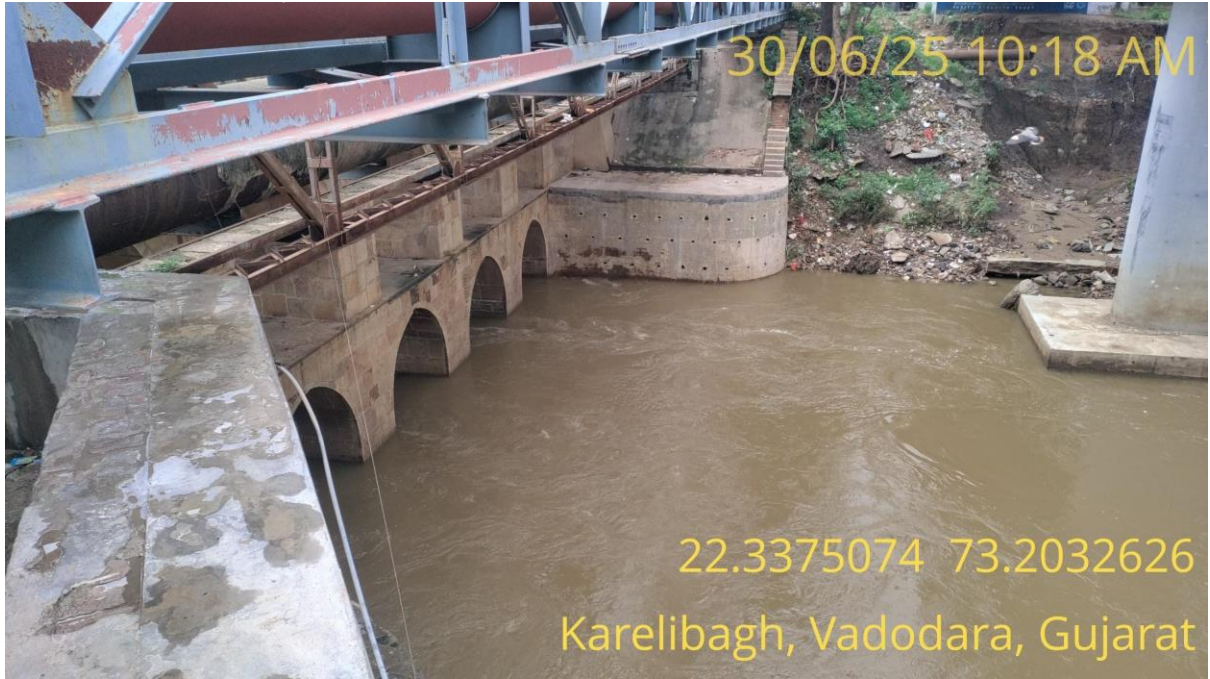
30.06.2025: Site Visit with VMC Officials

1. NHA I piers are within the riparian corridors and alter the river course.
2. Visible encroachment on the banks at south of Chetak Bridge.
3. C&D waste not removed from banks at many locations around Narhari Bridge.

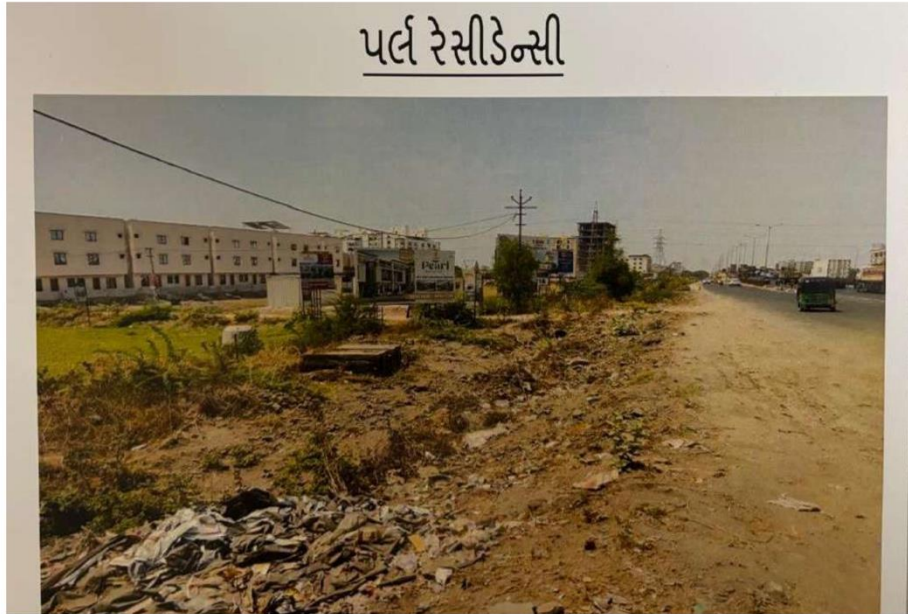
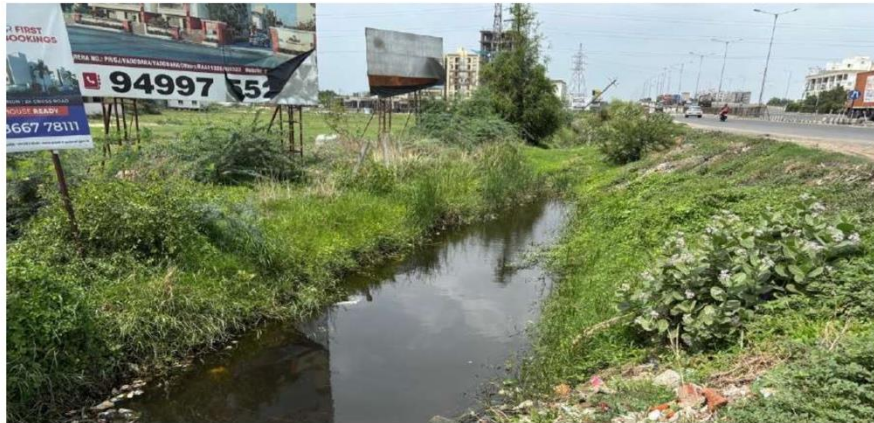
Pearl Residency

Drain Excavation Work At Ch 108+700 to 130+000 (BHS)

Before

After
(Drain cleared)

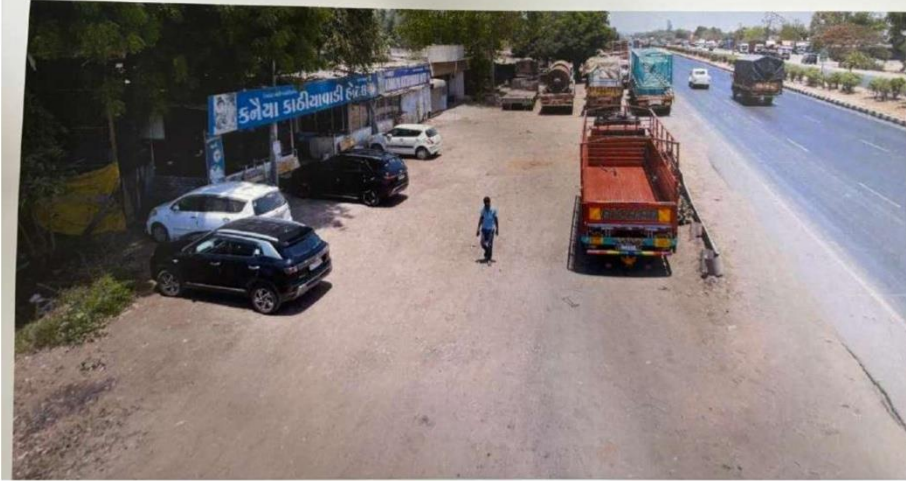
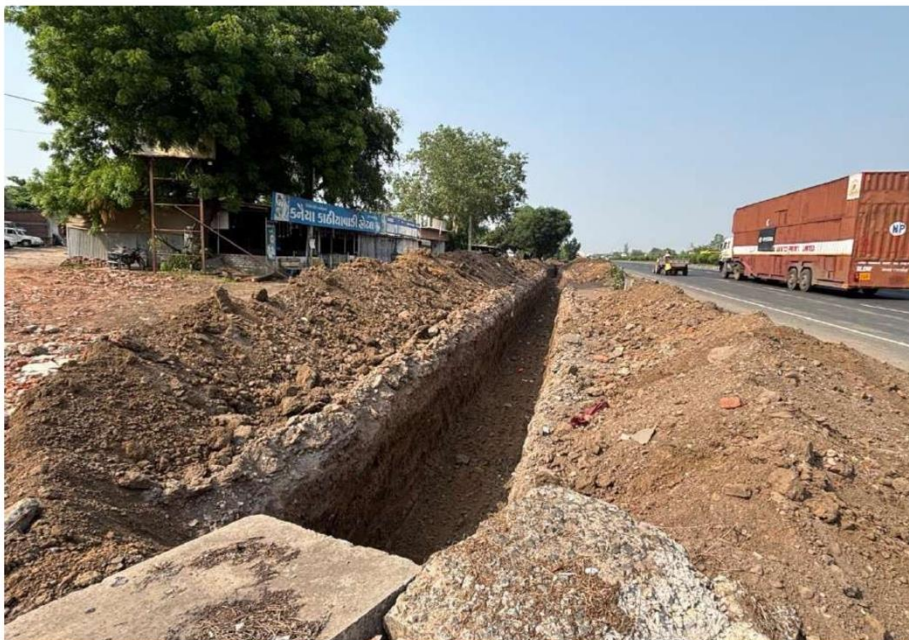
Kanaiya Kathiawadi Hotel

Drain Excavation Work At Ch 108+700 to 130+000 (BHS)

Before

કનેયા કાઠીયાવાડી, જામ્બુવા થી તરસાલી નેશનલ હાઇવે

After
(Drain Cleared)

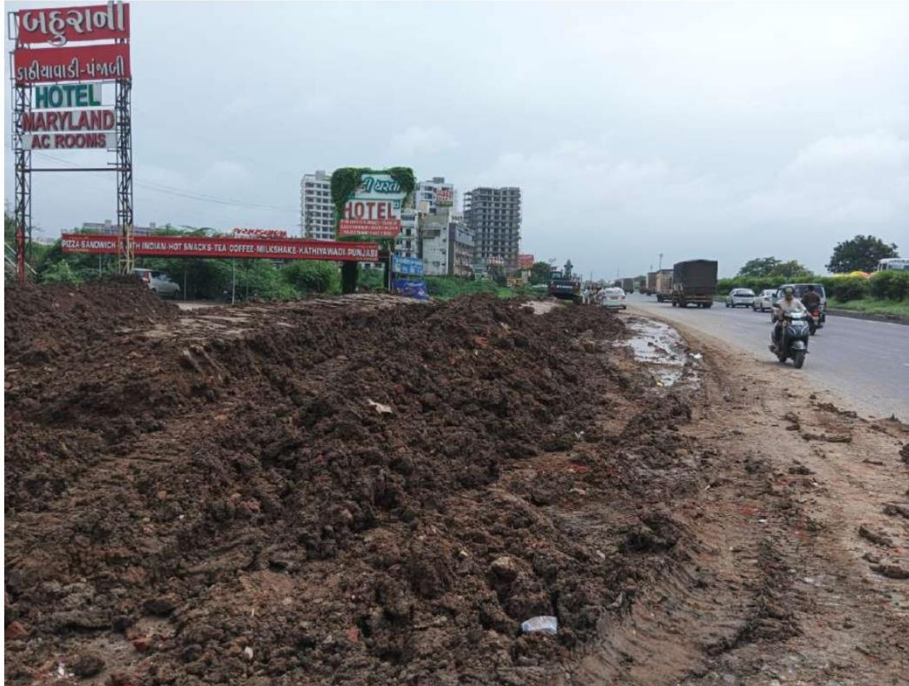
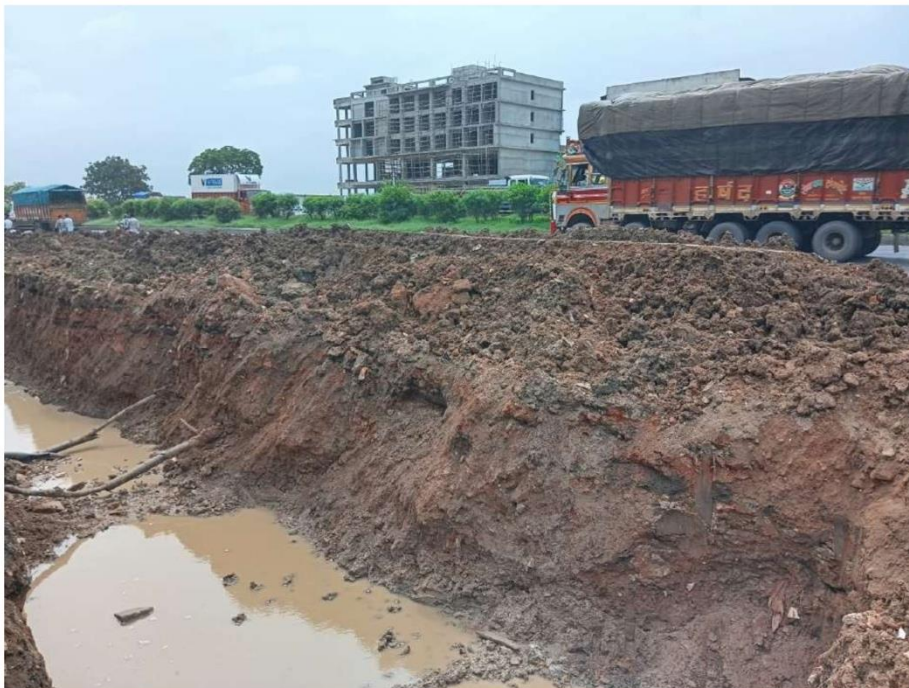
Bahurani Hotel

Drain Excavation Work At Ch 108+700 to 130+000 (BHS)
