Second Report of the Vishwamitri Committee

(Constituted by the Hon'ble Gujarat State Human Rights Commission)

HRC/2024/PRESS/205/Vadodara City/legal-1

20 July 2025

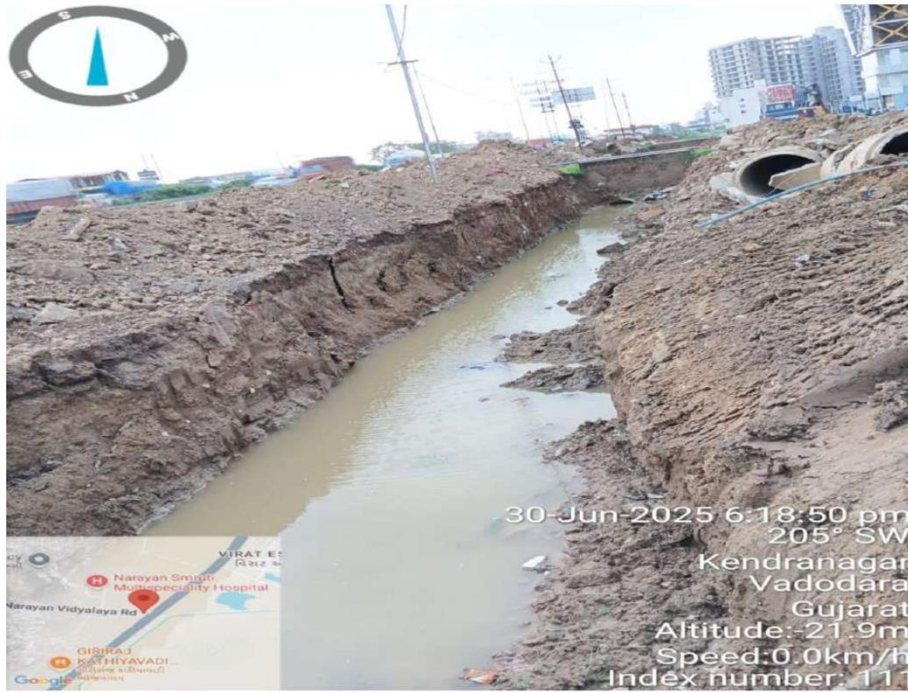
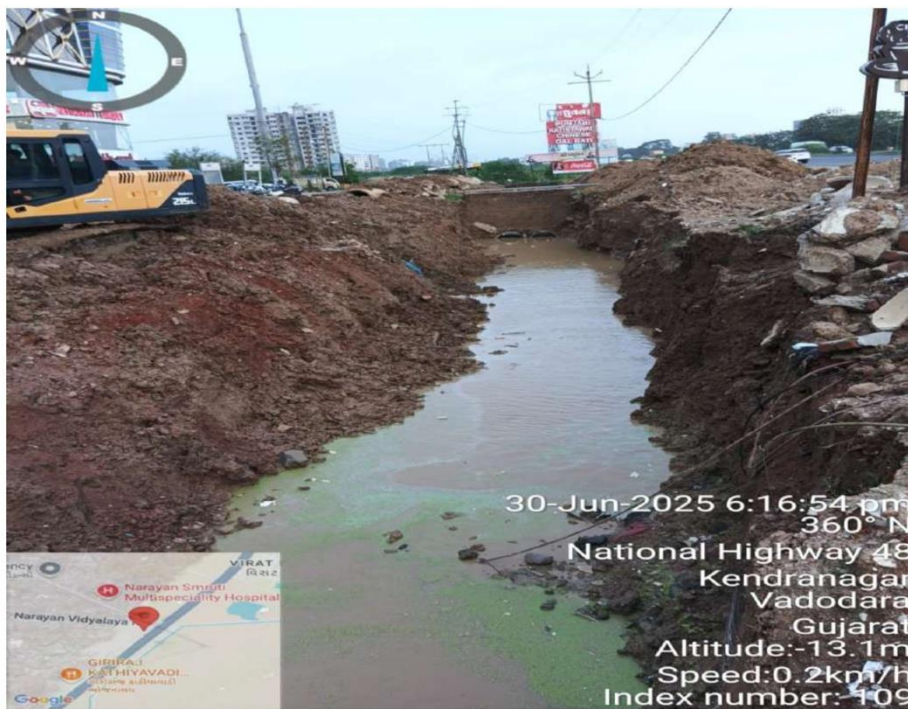
Shiddheshwar Business Harbour

Drain Excavation Work At Ch 108+700 to 130+000 (BHS)

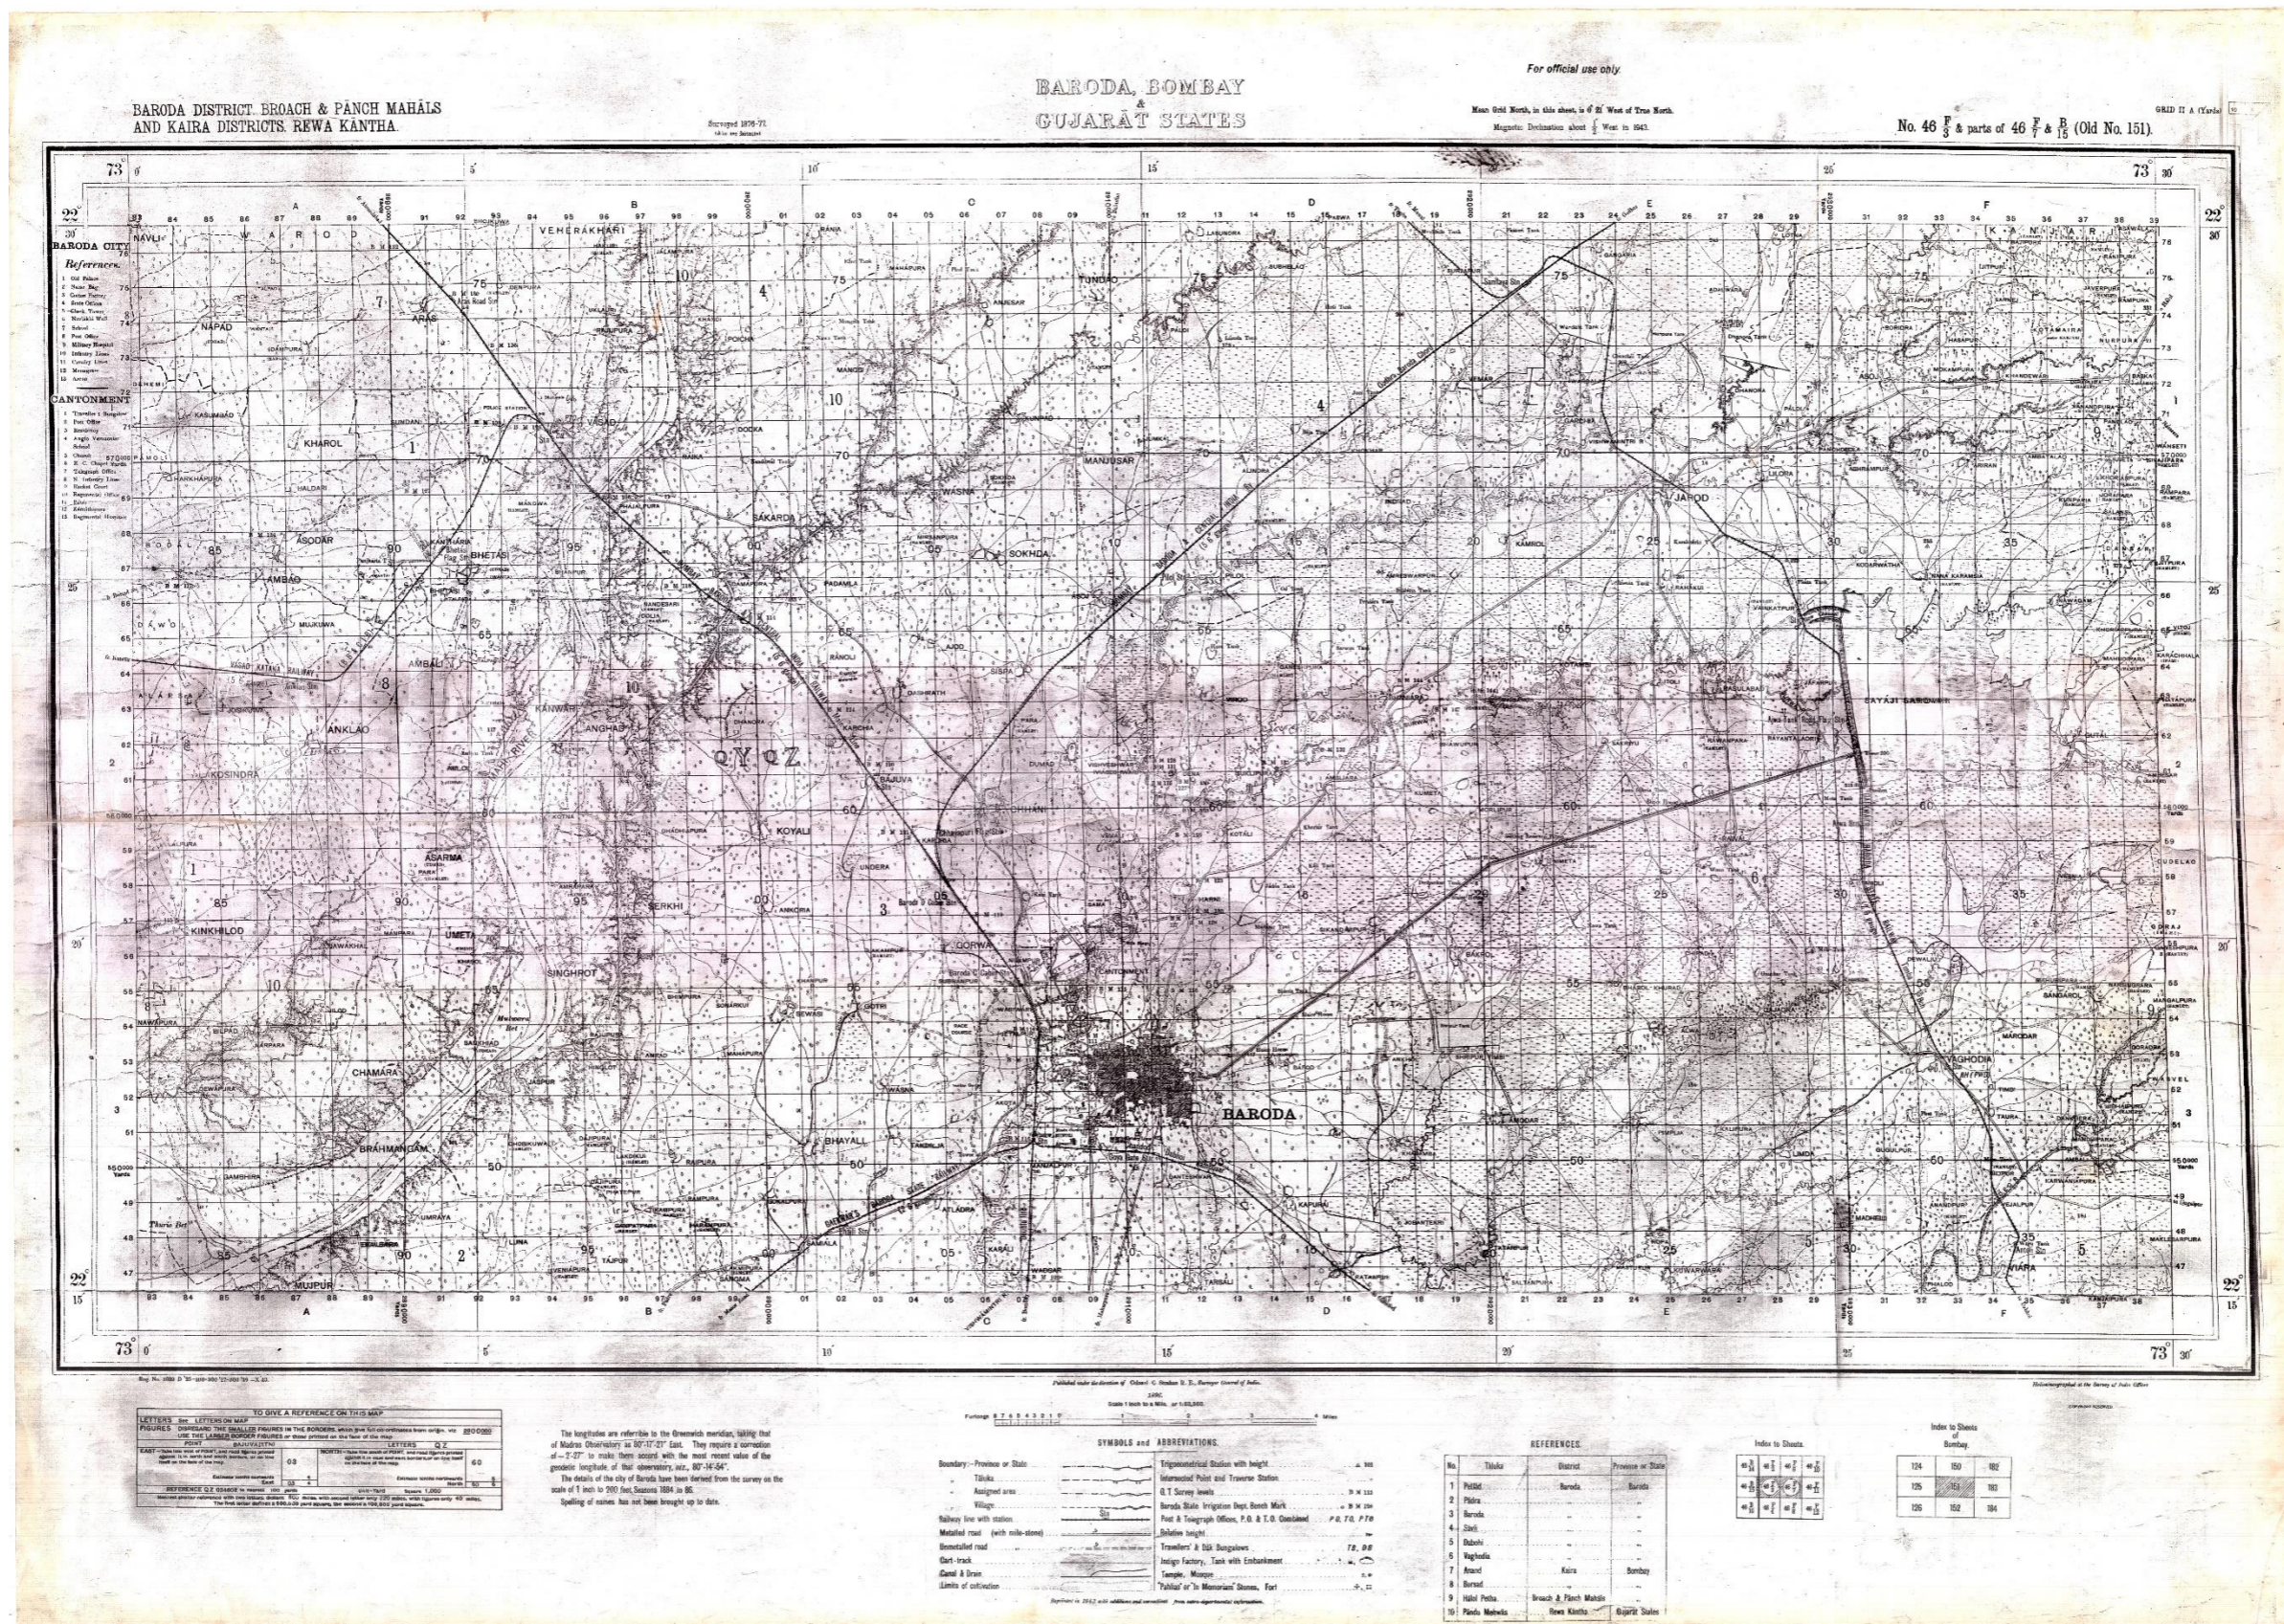
Annexure XVI: Topo Sheet of Erstwhile Vadodara Region dated 1896

functions need to be established. For this purpose, historical maps and topo sheets from previous decades should be referred to identify lost connections and scope for revival. One such topo sheet from 1896 is annexed herewith as Annexure XVI.
