Fourth Report of the Vishwamitri Committee

(Constituted by the Hon'ble Gujarat State Human Rights Commission)

HRC/2024/PRESS/205/Vadodara City/legal-1

13 February 2026

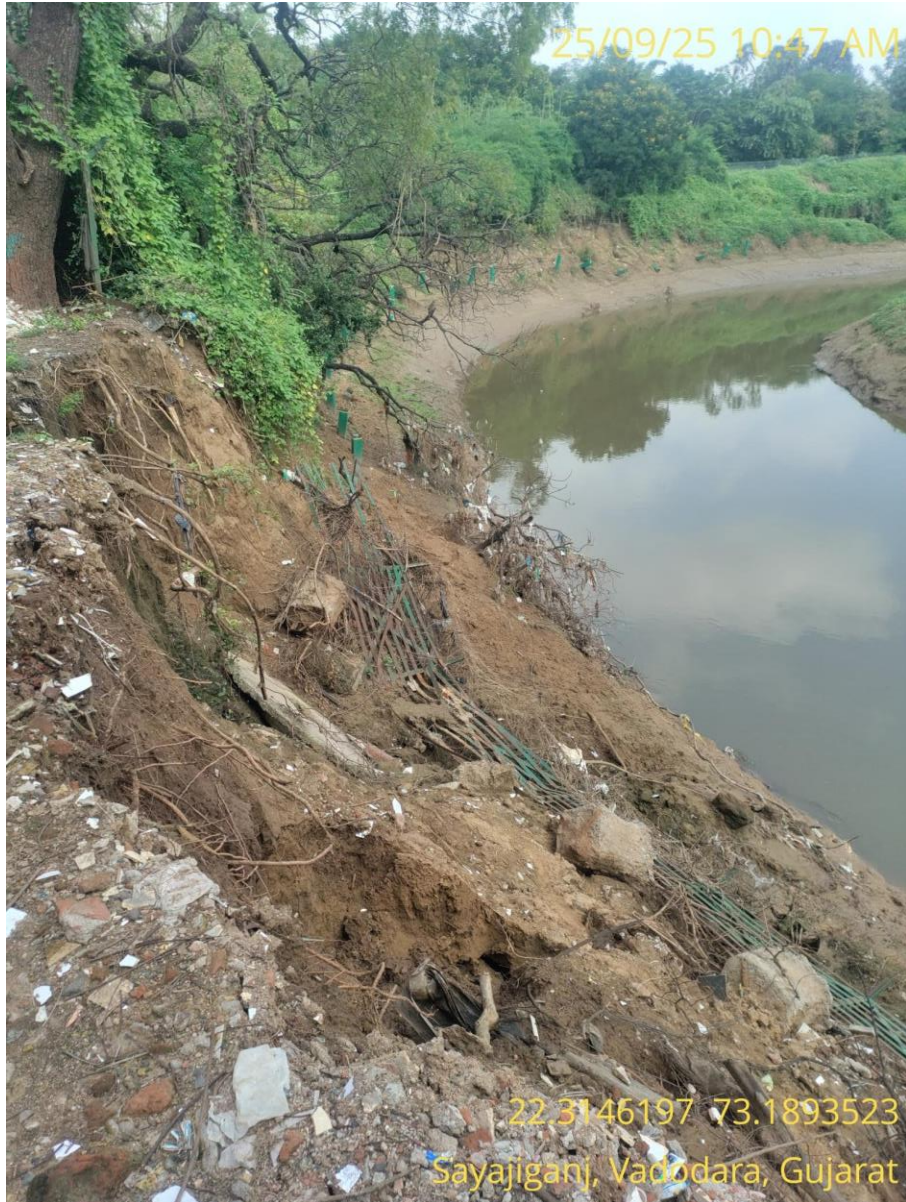
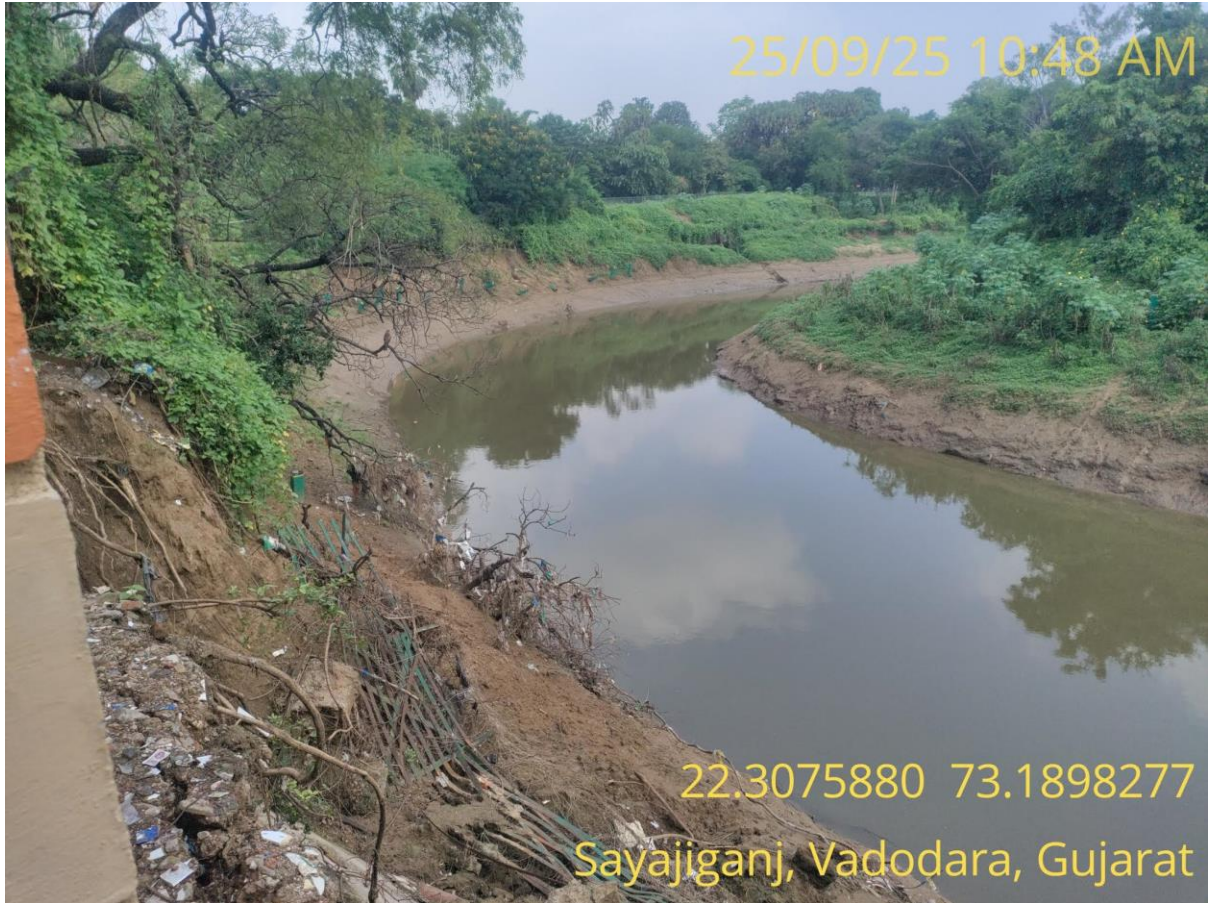
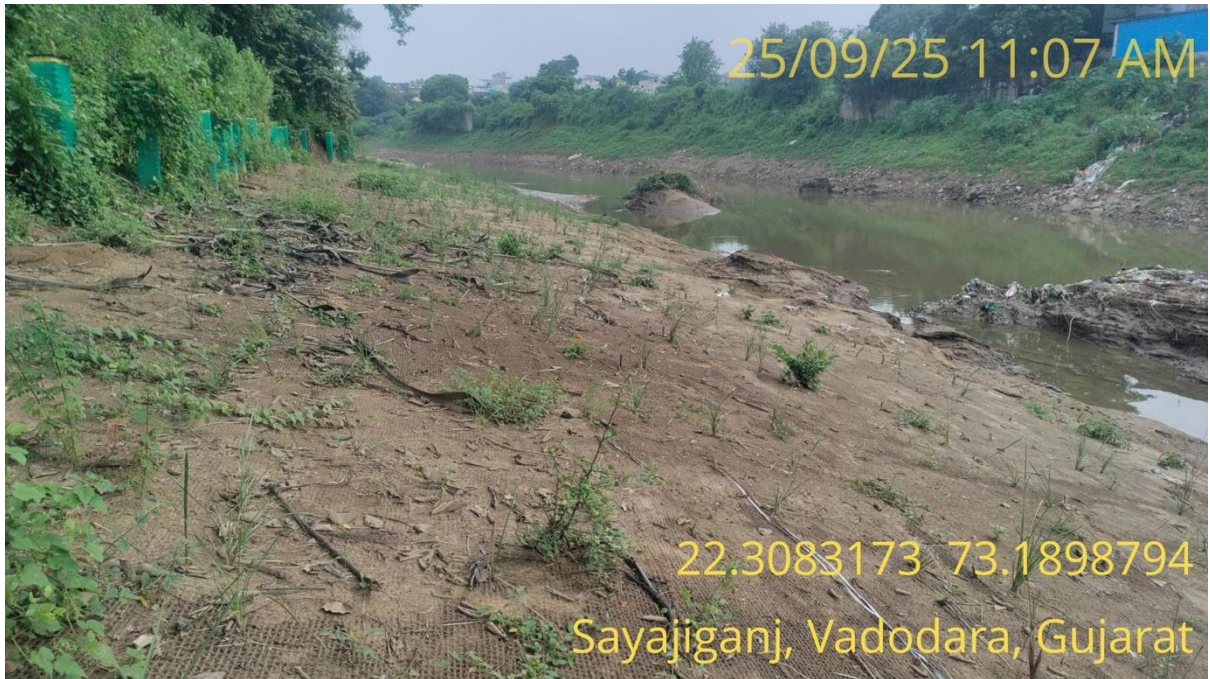
3. It was observed that certain trees that were exposed during the desilting works and not protected by coir were uprooted. It was suggested that these fallen trees be removed from the course of the river.

4. It was observed that the areas of the bank (near the zoo) that were not stabilised by coir has undergone erosion, while the banks where coir has been installed were stabilised. Additionally, alluvial soil was deposited along the banks on the coir and herbs, grasses and new plant recruits had emerged. It can be surmised that the coir has acted as a reinforcement and contributed to the stabilisation of the banks.

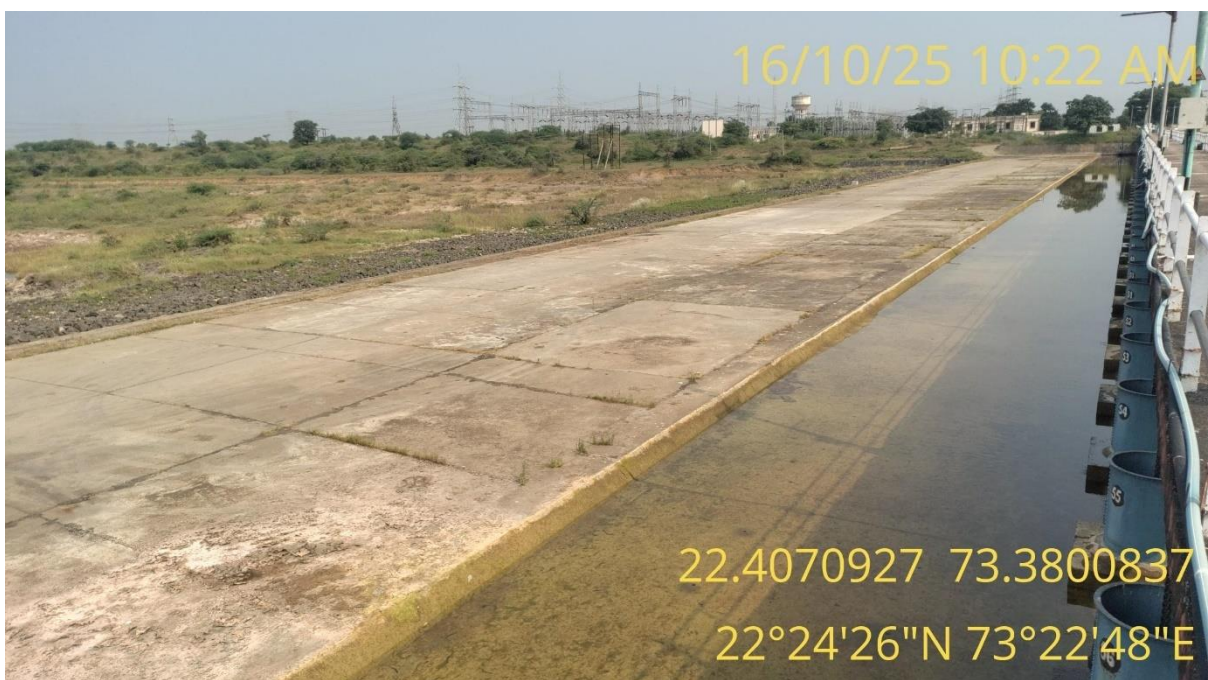
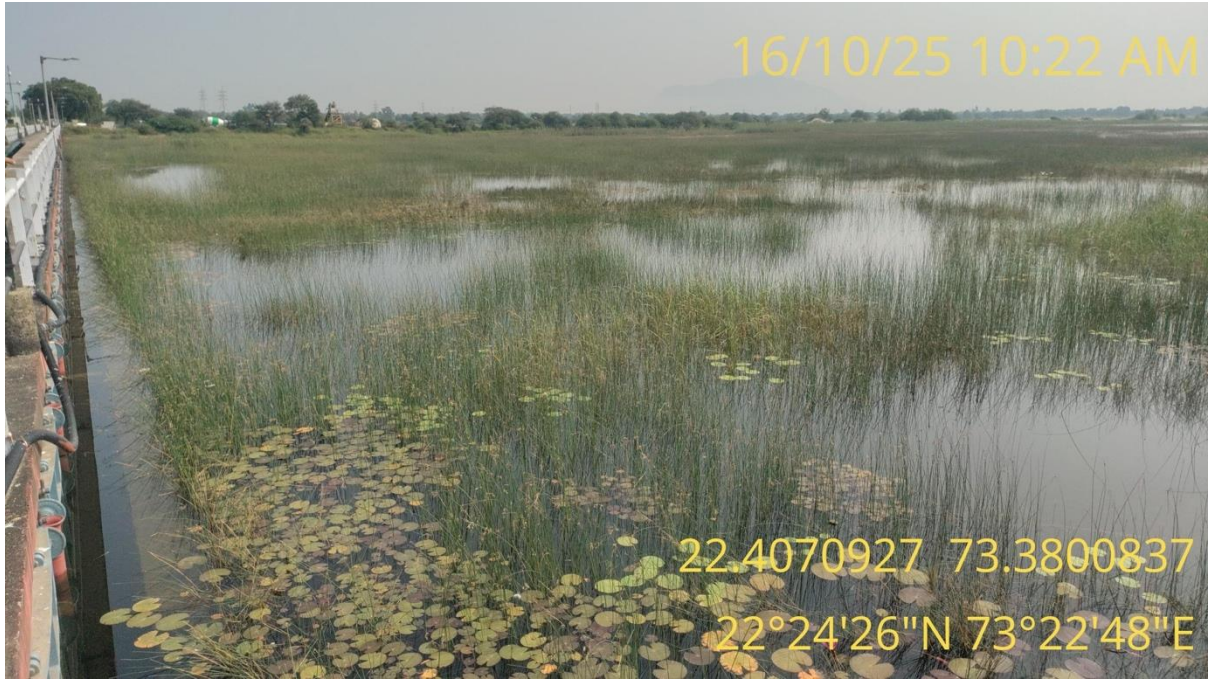
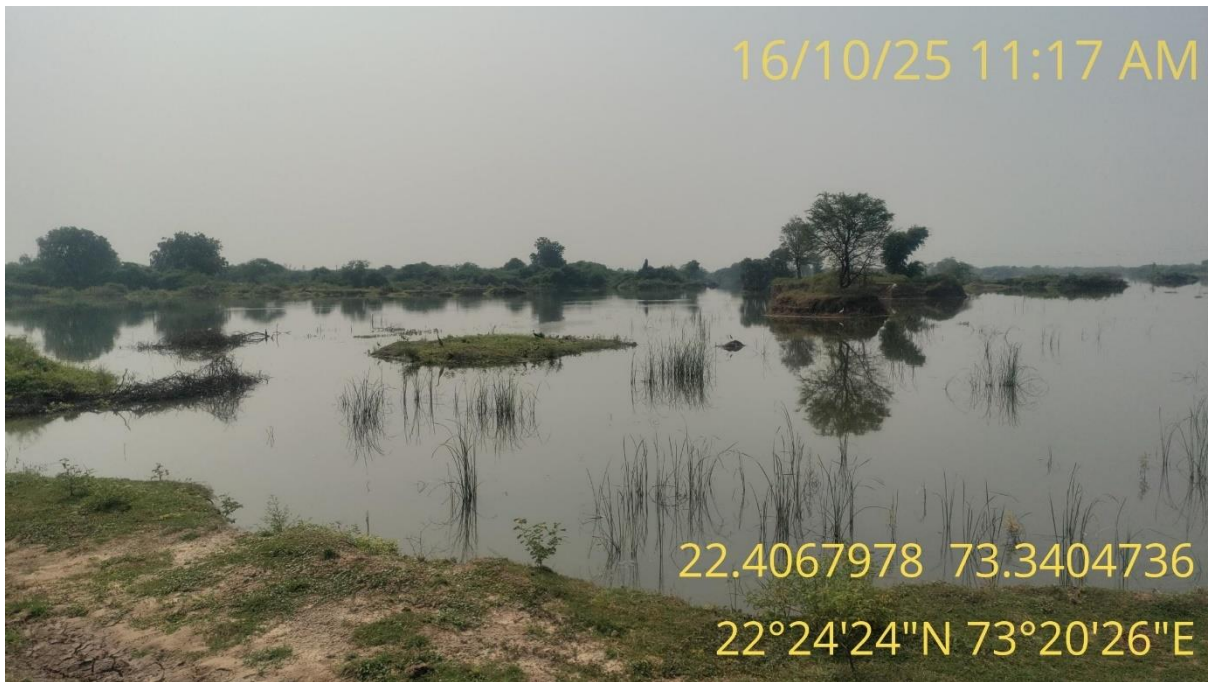
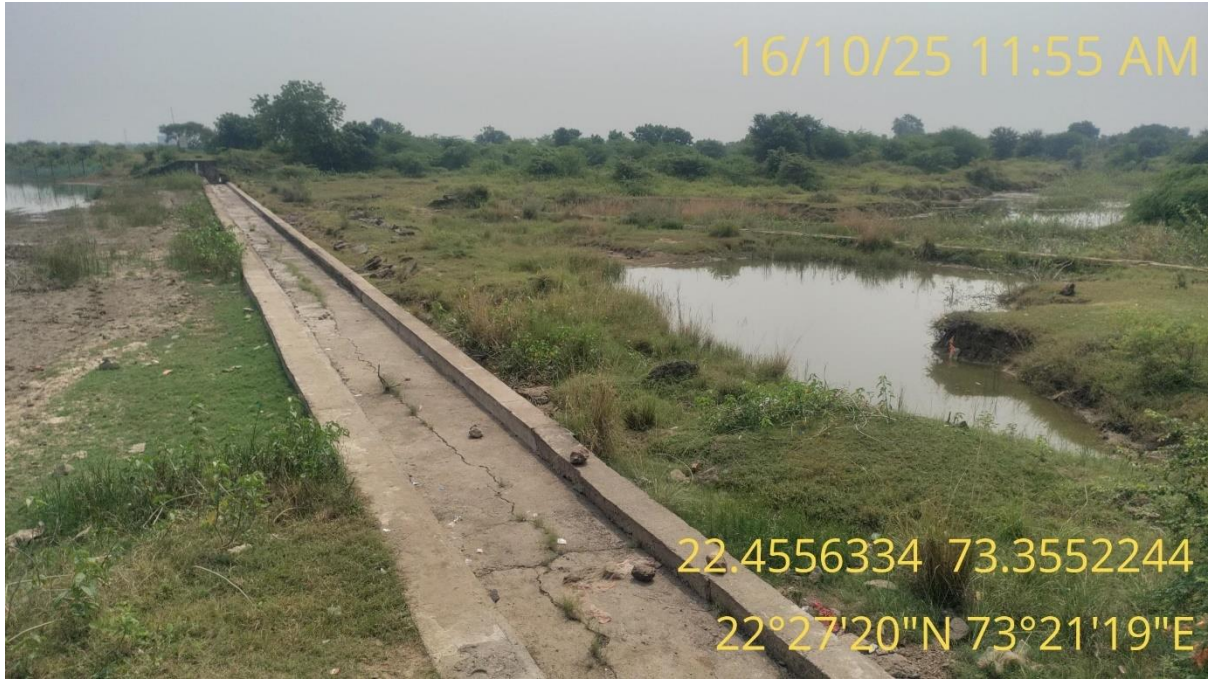
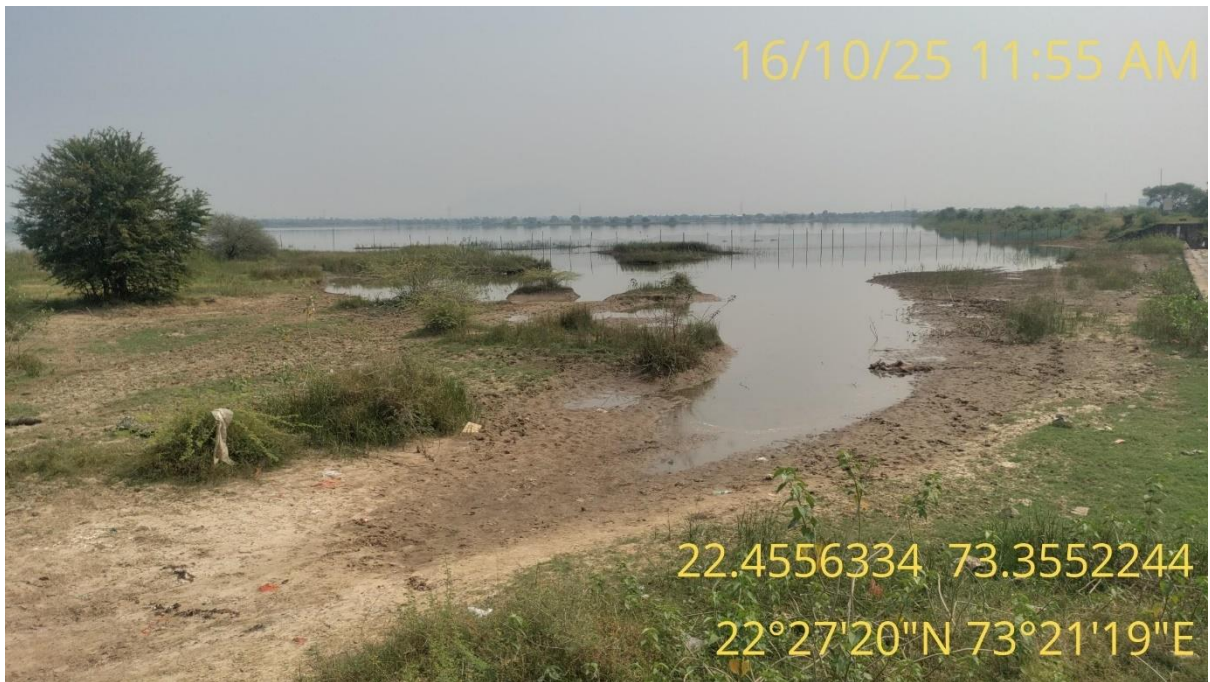
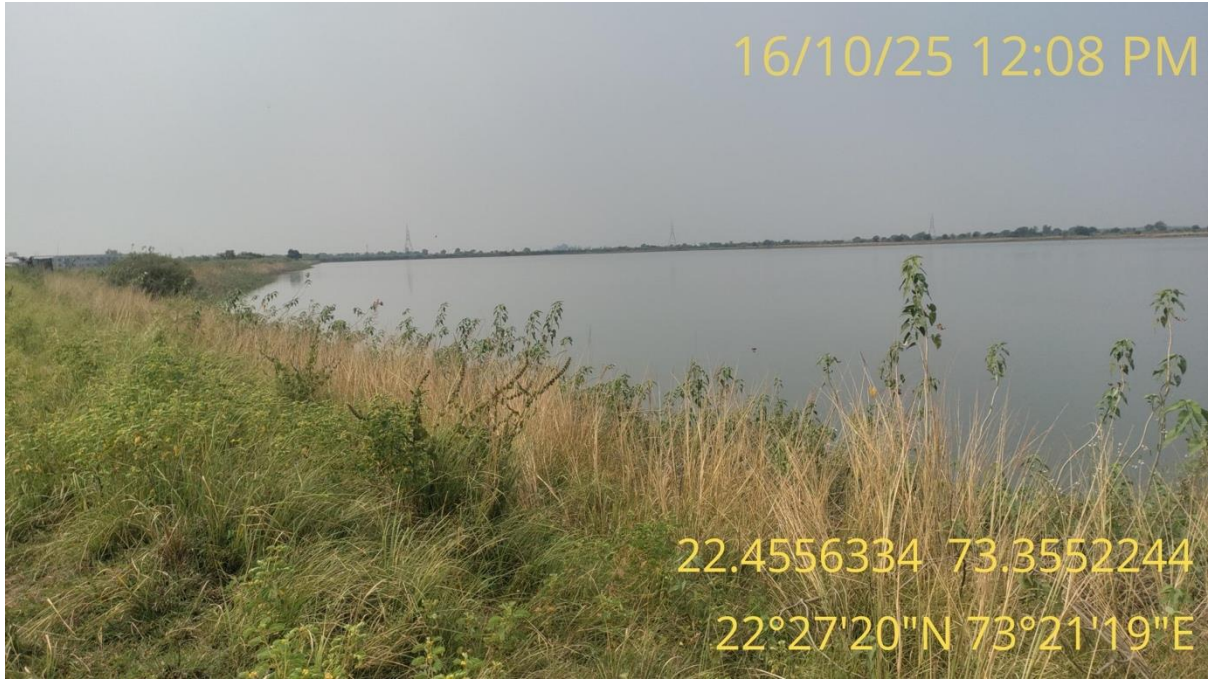
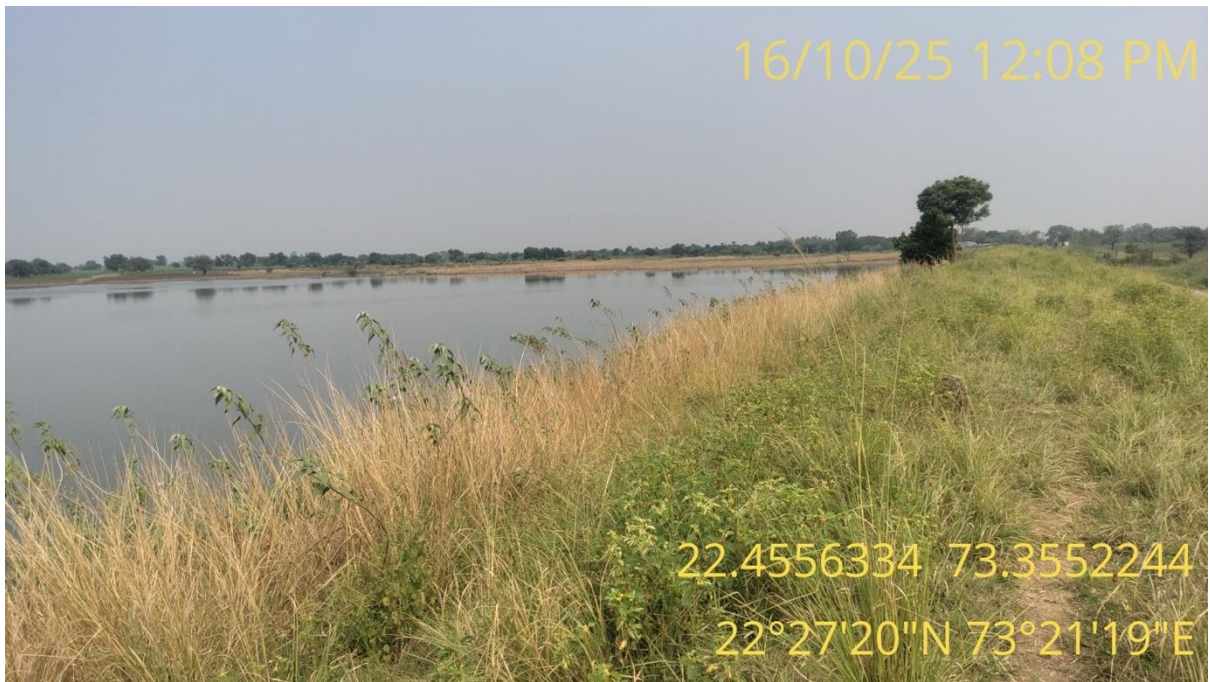
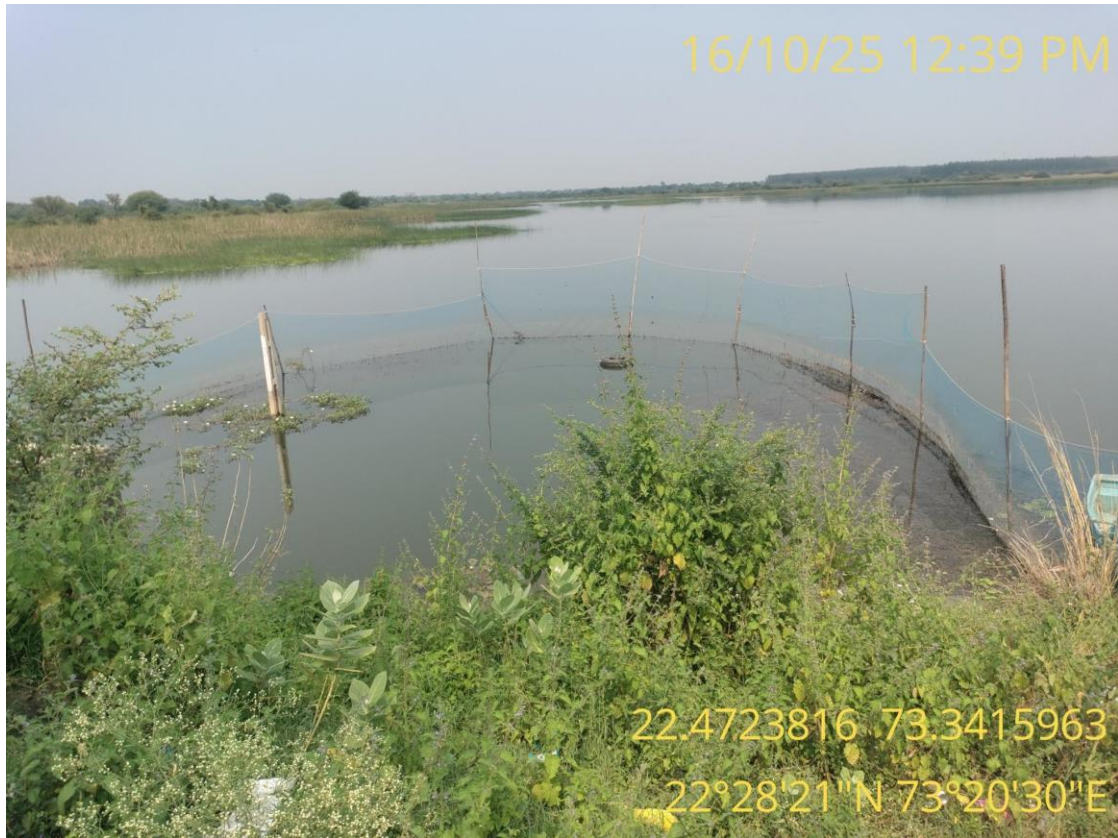
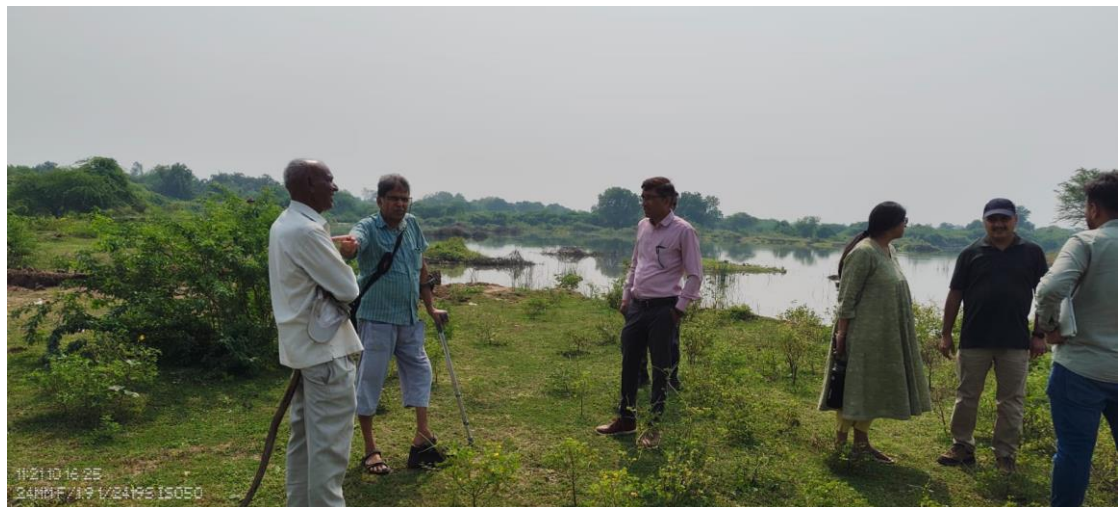
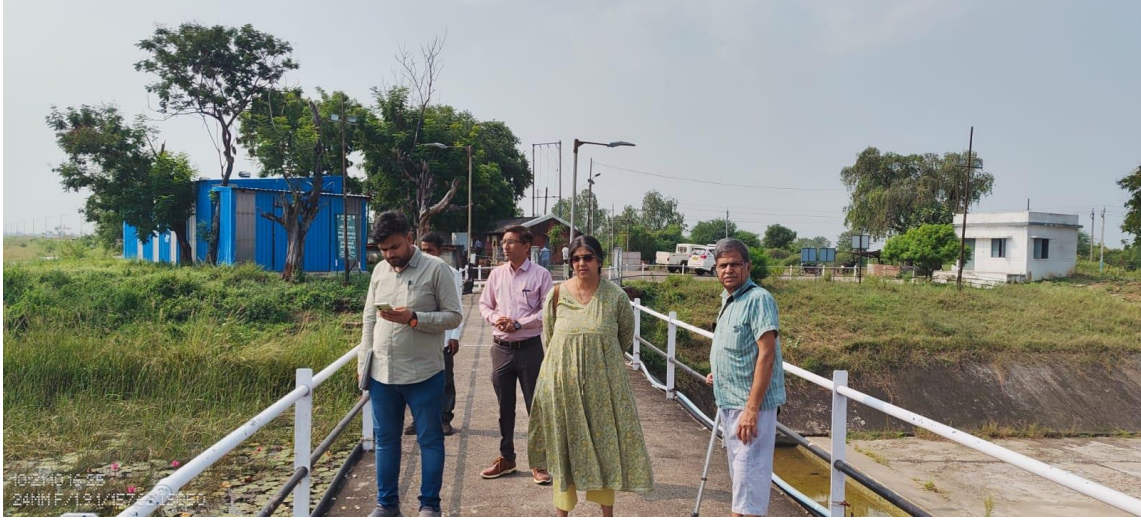
16.10.2025: Field Visit to Upstream Areas with VMC Officials.

Location: Ajwa, Pratappura, Vadadla, and Haripura Reservoirs

1. It was observed that Ajwa, Pratappura, Vadadla, and Haripura reservoirs were at full capacity.
2. It was reported by a local villager that the increased catchment of the Pratappura reservoir prevented floodwaters in Vadodara city and also helped towards groundwater recharge of the surrounding villages, that will eventually contribute towards agricultural and livestock activities.
3. The Dena detention pond was inaccessible due to muddy access road.

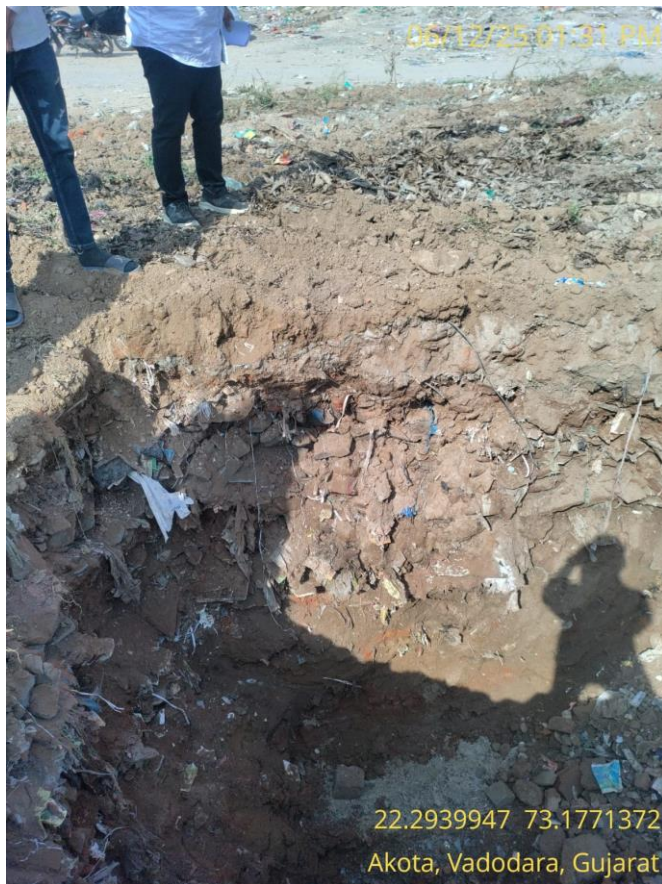
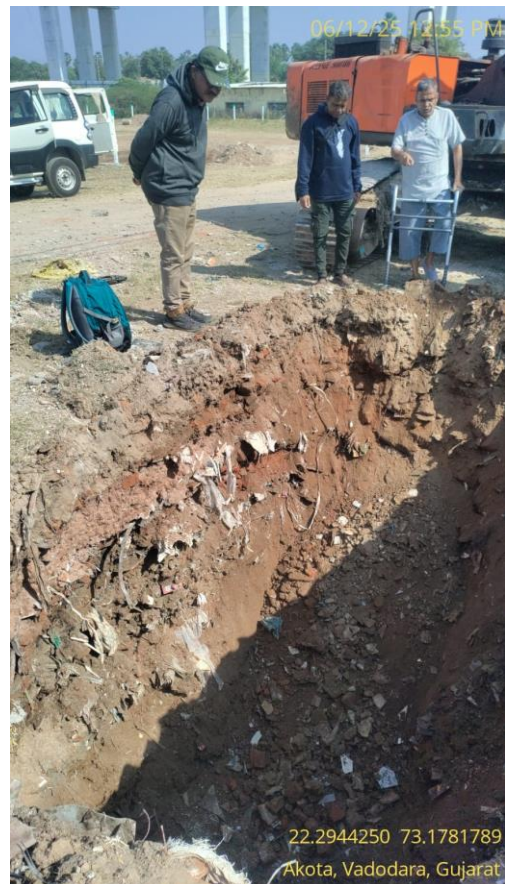
1. Minimum pit depth at 2 mt. from new ground level.
2. Debris was identified as 4 mt. depth
3. The presence of certain overhead lines was a limitation to the JCB machine to dig deeper.

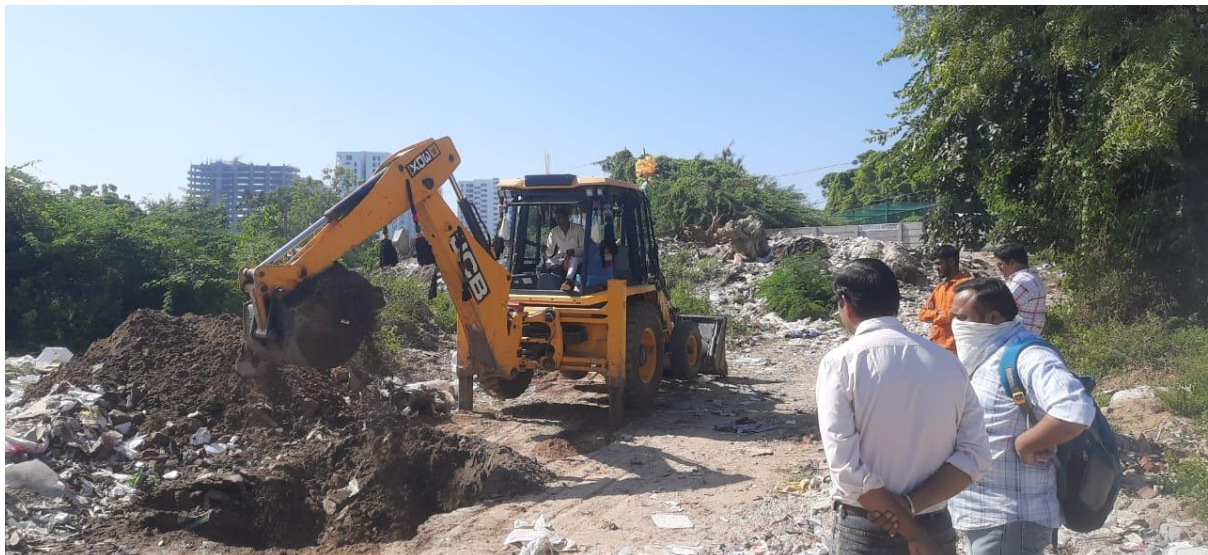
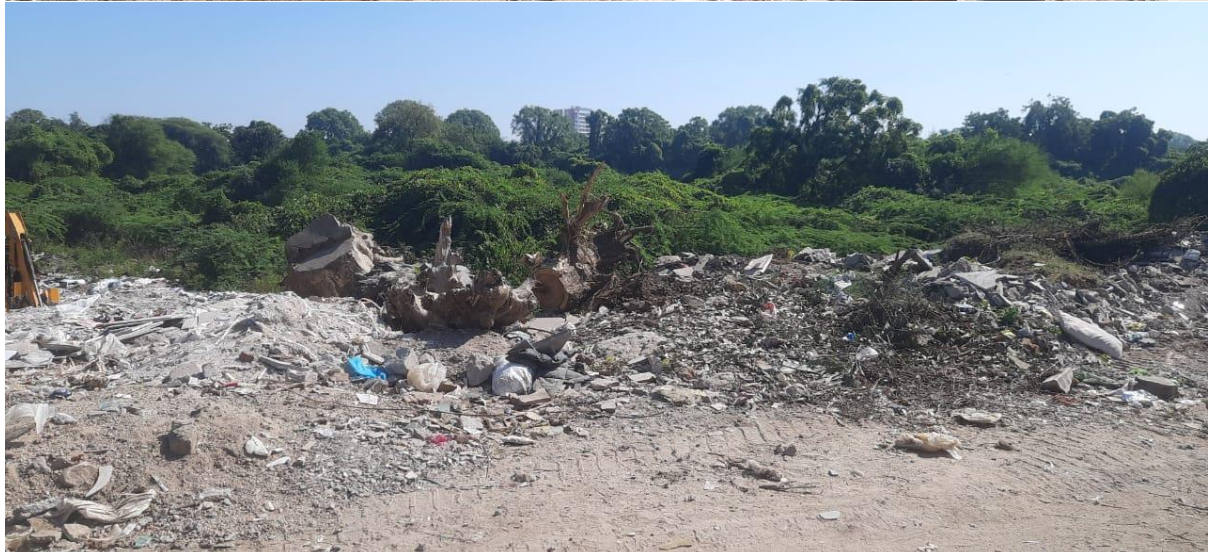
09.12.2025: Field Visit with VMC SWM Team and Consultants
Facile Maven for Sample Pit.

1. Pits were dug at 2 locations at the same site.
2. Waste identified below 1 mt.

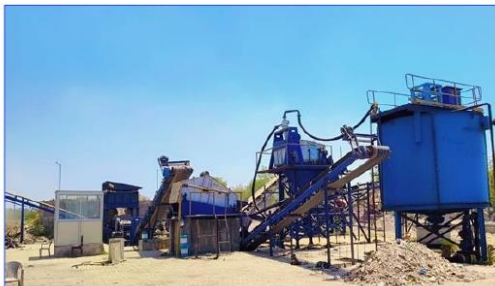
Construction and Demolition Waste

- Sent for crushing at the recycling plant at Atladara
- It is plan to use for preparing 1) Paver block 2) Curb Stone 3) Chamber Cover

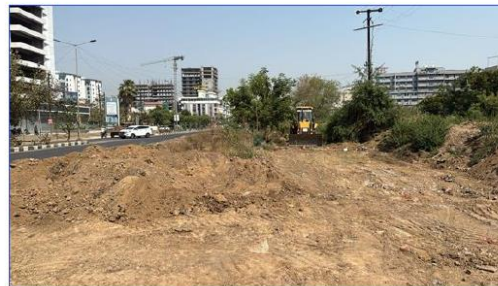
Soil

- Use for creating "Linear Park" and "Nagarvan" at Bill and for embankment protection.
- Excavated Soil distribution free of cost in vicinity area of city. Vis NGO, VMC Garden plot, Religious Institute. Etc.

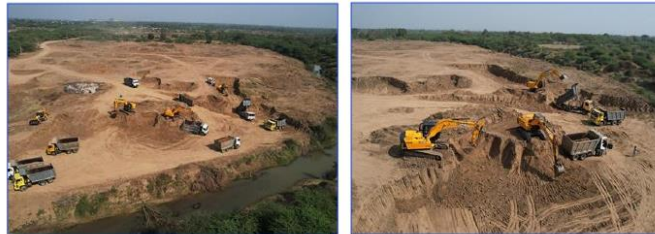
- **Removal of 2.5 lakh cubic meters Sediments**
- Area: 50,000 square meters is to be deepened by 5 Meters
- Work Started on: 24-02-2025
- Progress : **2.50 lakh cubic meters (100% completed)**
- **25 Cr. Litre Capacity New Lake Created**
- Approximately 3 Hitachi excavators and 20 dumpers were being used in this operation.

During Work

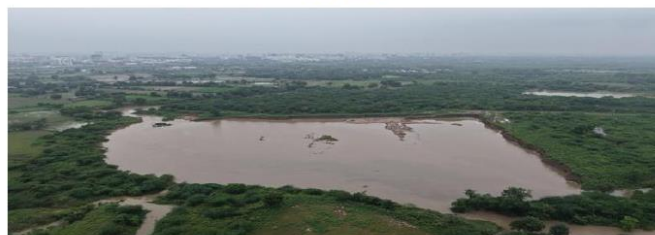
After work Lake Formation (Picture dated 05/09/2025)

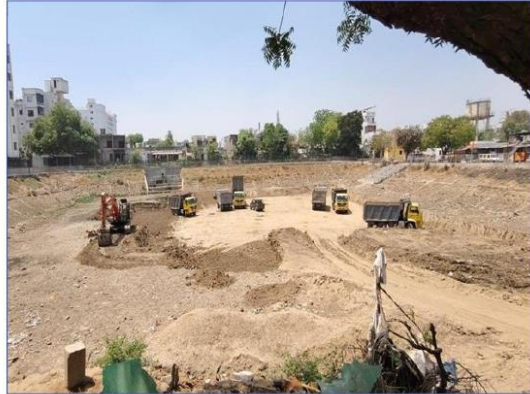
Making outlets of different lakes (11 lakes)

SN	Name of the Lake	Zone	Current Status
1	Kapurai lake	South	Work Completed
2	Ghaghratia lake	South	Work Completed
3	Kashivishwanath lake	North	Work Completed
4	Bhayli lake	West	Work Completed
5	Atladara lake	West	Work in Progress
6	Vemali lake	North	Work in Progress
7	Bil Lake	West	Work in Progress
8	Ramnath lake	East	Survey in Progress
9	Kalali lake	West	Survey in Progress
10	Sarsiya Lake	East	Survey in Progress

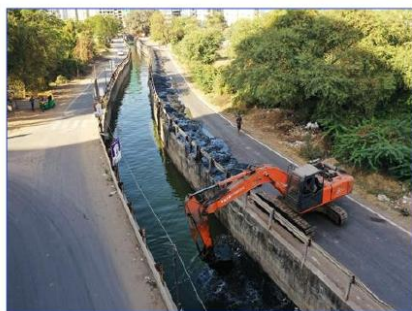
Gotri-Bhayli Channel

- Total length of the storm water channel: 180 kms
- Purpose: To Mitigate flood and to Recharge ground water
- Progress till date: **180 km length completed (100% completed)**

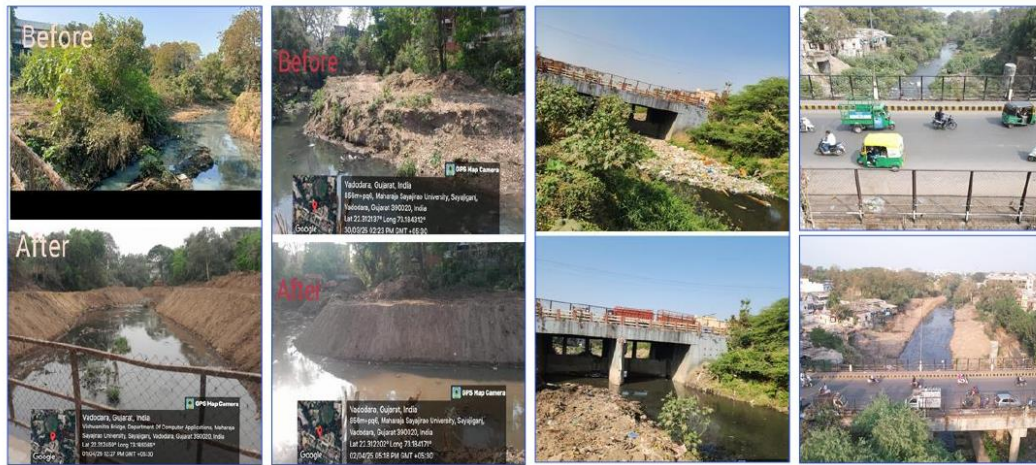
Before & After Images – North Zone

Stormwater Channel behind M.S. University

Kasamala Crematorium Bridge

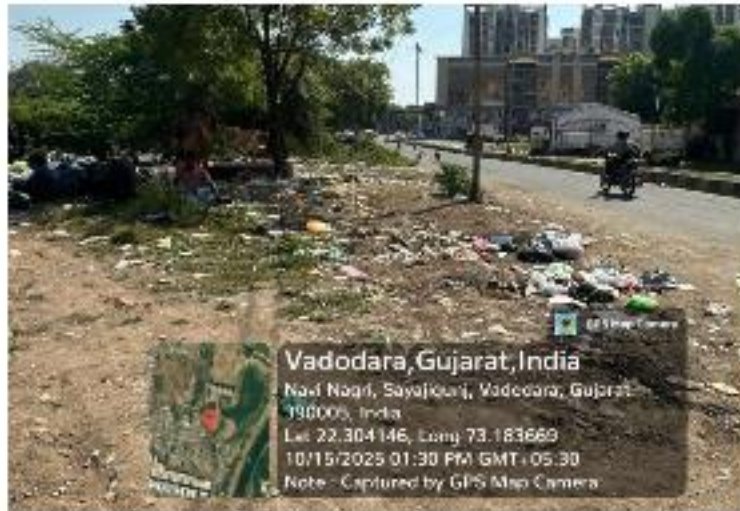
1. Navi Nagri – Bharvad Vas – Sama

The Vishwamitri River, flowing through Vadodara city, has been subjected to environmental pollution due to unregulated disposal of C&D waste along its banks. Unauthorized dumping of debris such as soil, bricks, concrete, and mixed waste has led to degradation of riverbank ecosystems and unpleasant river side aesthetics.

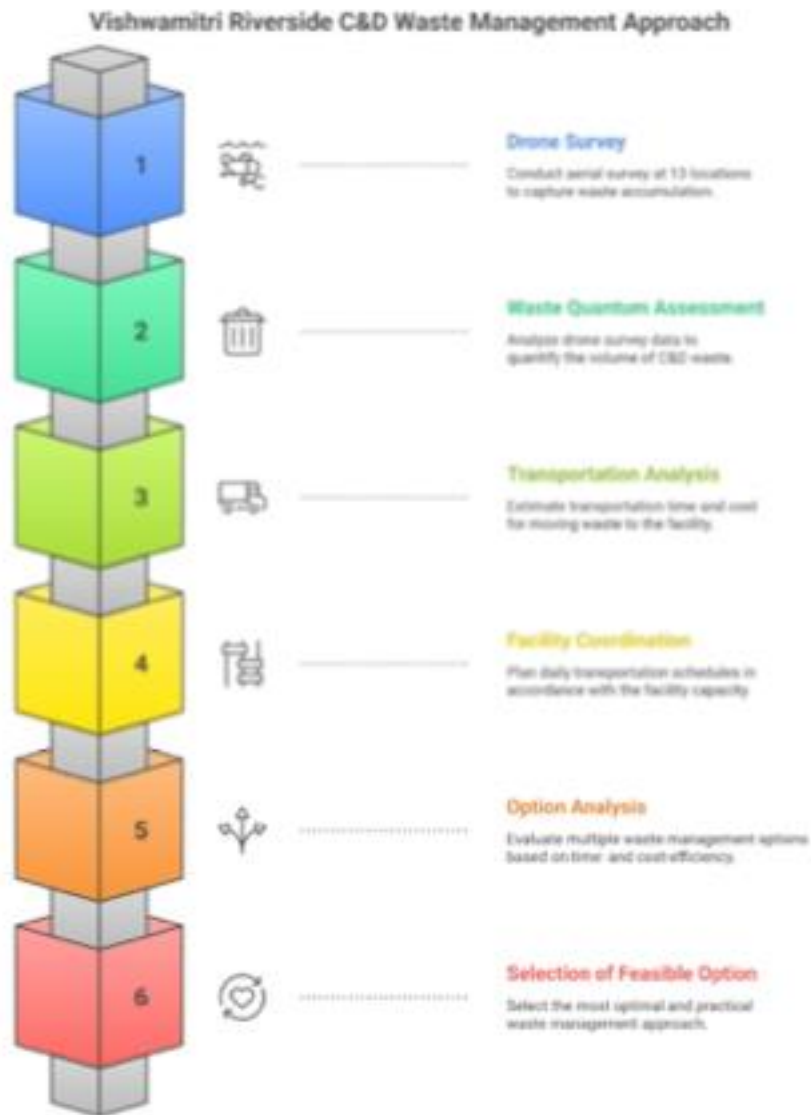
Figure 4-1 Approach for C&D waste management alongside Vishwamitri River in Vadodara

Proper management and removal of the accumulated C&D waste is critical to ensure hygiene, prevent environmental degradation, and maintain aesthetic and sanitary conditions along the Vishwamitri riverside. For approaching this, following project methodology has been considered:

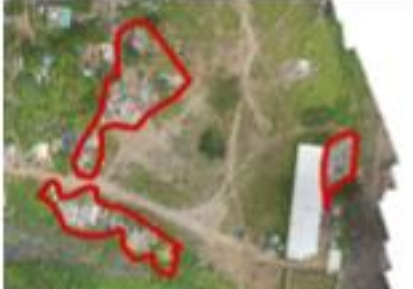
Sr. No.	Location Name	Image for Reference	Total No. of Pockets
1	Behind Akota Smashan, Railway Bridge (B/h Akota)

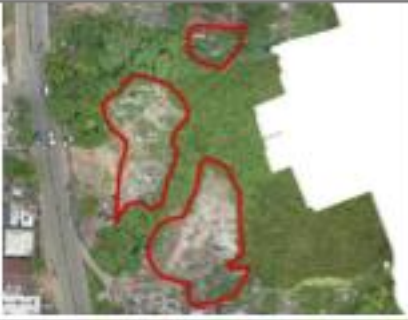
Sr. No.	Location Name	Image for Reference	Total No. of Pockets
2	Bhimnath Bridge, Near Sayaji Hotel (Bhimnath Bridge-3)
